## Annual Inspection

West Suffolk Parks

Hargrave

Playing Field, School Cottages, off Bury Road,  
Hargrave, IP29 5HR

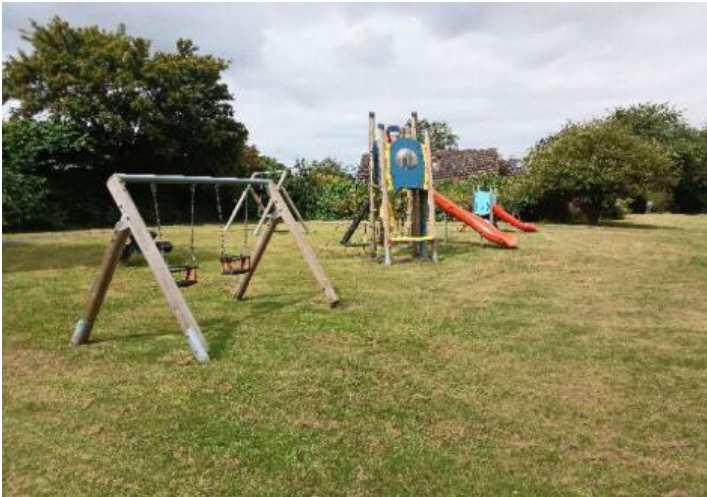
**Finding:** It is recommended that signage, with information including the site address, contact information for maintenance issues and emergency contact details are provided for the facility

**Action:** Provide in accordance with the recommendations

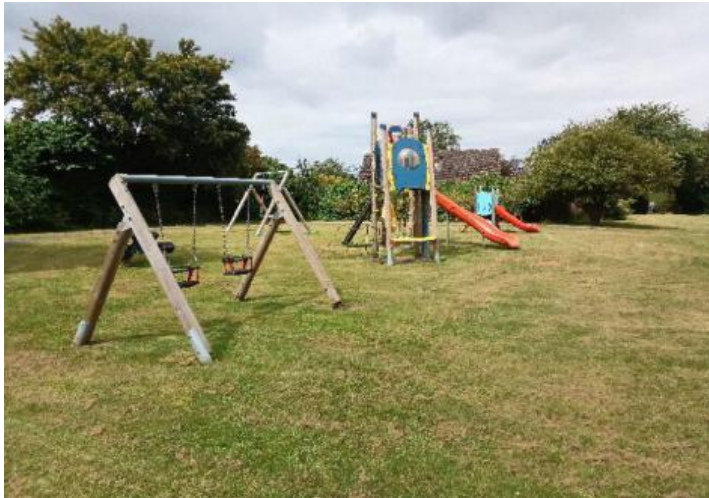
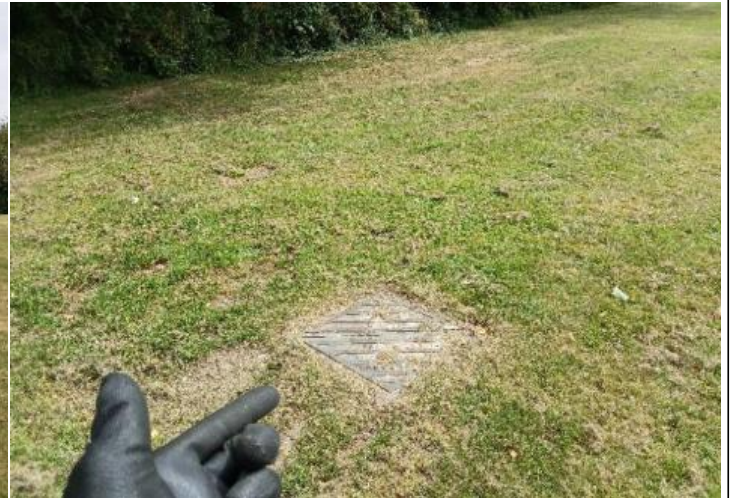
There are trip hazards at the edges of the drain cover - Reinstate surrounding surface levels to remove the trip points

**Finding:** There are trip hazards at the edges of the drain cover

**Action:** Reinststate surrounding surface levels to remove the trip points

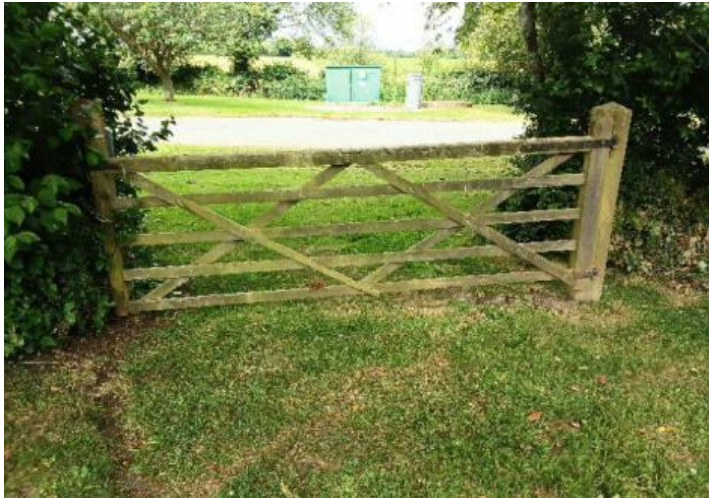
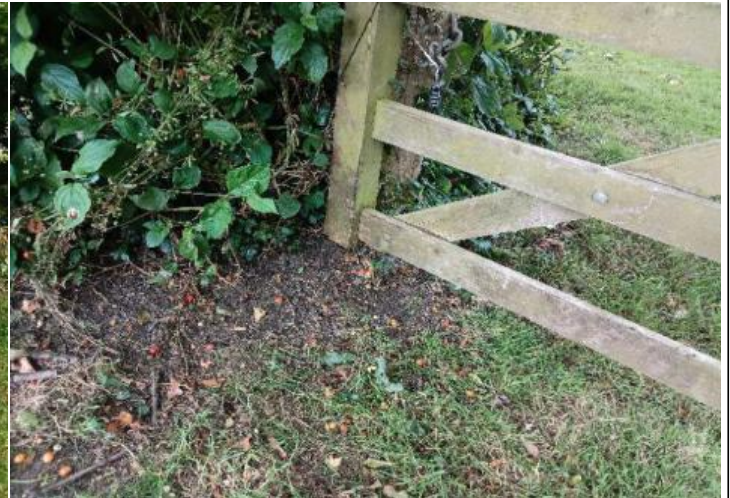
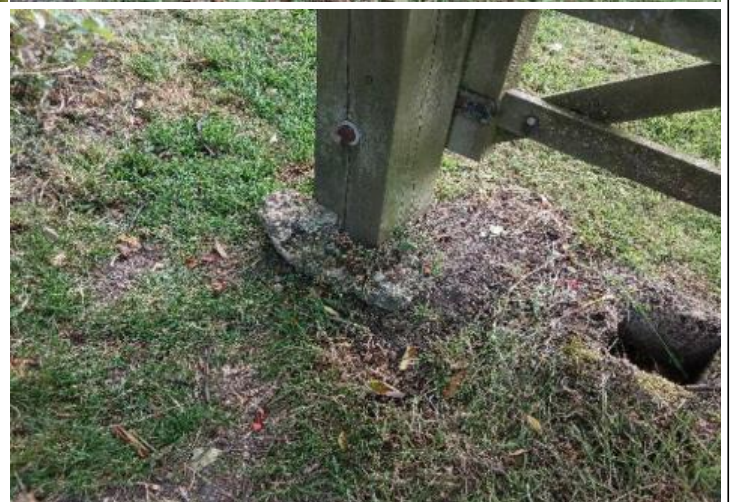
The area under the gate has eroded leaving uneven areas, or the concrete foundations exposed, resulting in trip hazards at the entrance/exit to the playground - Reinstate to level with surrounding surfaces

**Finding:** The area under the gate has eroded leaving uneven areas, or the concrete foundations exposed, resulting in trip hazards at the entrance/exit to the playground

**Action:** Reinststate to level with surrounding surfaces

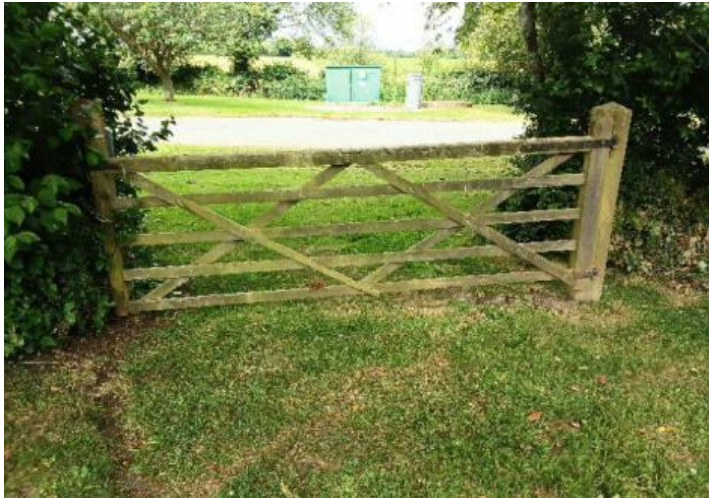
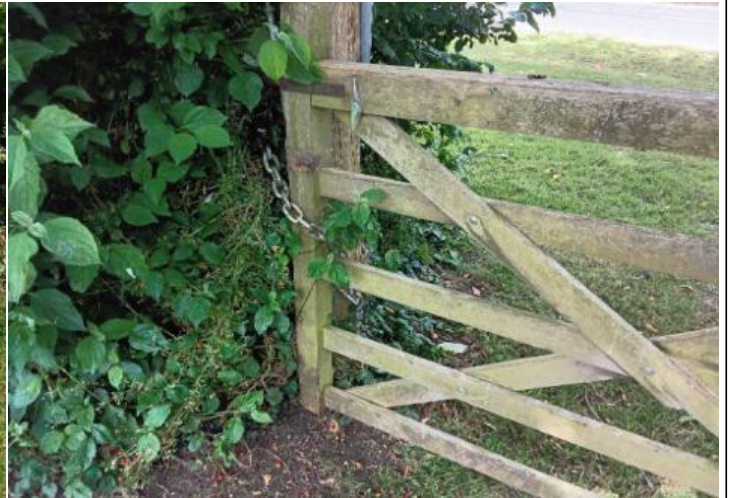
**Finding:** The maintenance gate was correctly padlocked at the time of inspection, however this means that the inspector was unable to fully assess the gate

**Action:** Ensure that there are 12mm gaps throughout the full range of motion on gate/s and between leaves where relevant

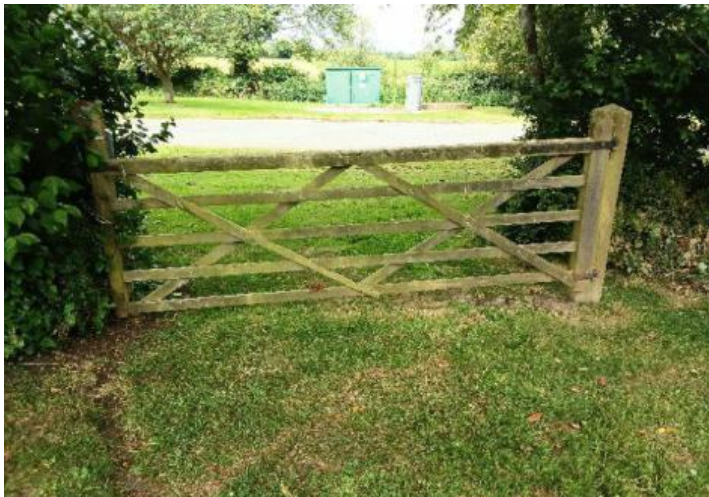
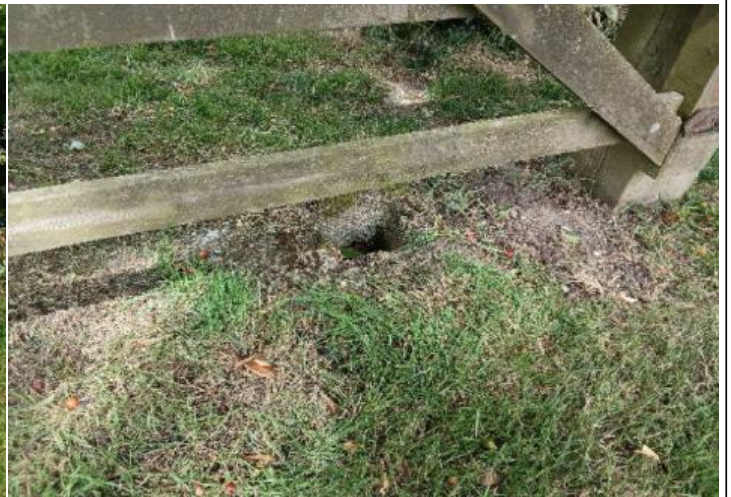
**Finding:** There is an old post socket under the gate

**Action:** Remove the concrete and reinststate to provide a uniform surface

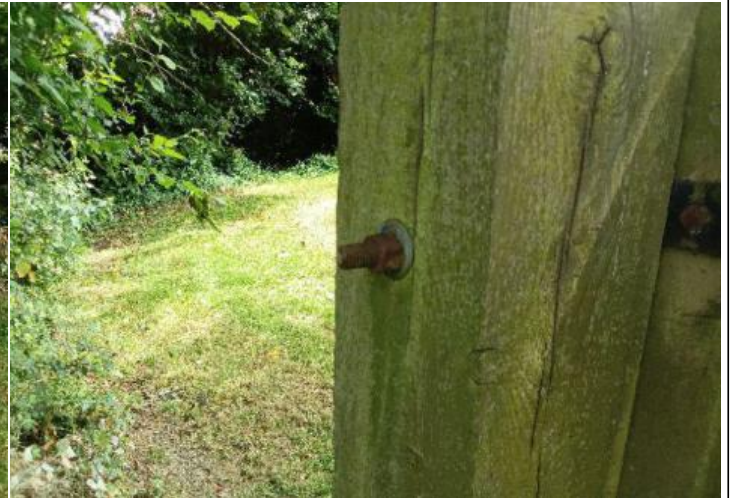
**Finding:** There are projecting bolt thread(s) present

**Action:** Remove excess thread length and deburr or provide cap

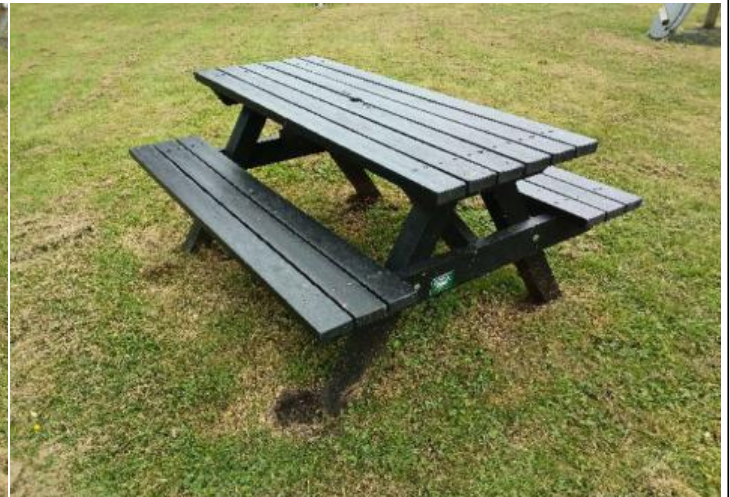
**Finding:** The table/s is/are not secured to the ground and there is some potential for the item/s to be moved within falling spaces of equipment

**Action:** Secure to the ground

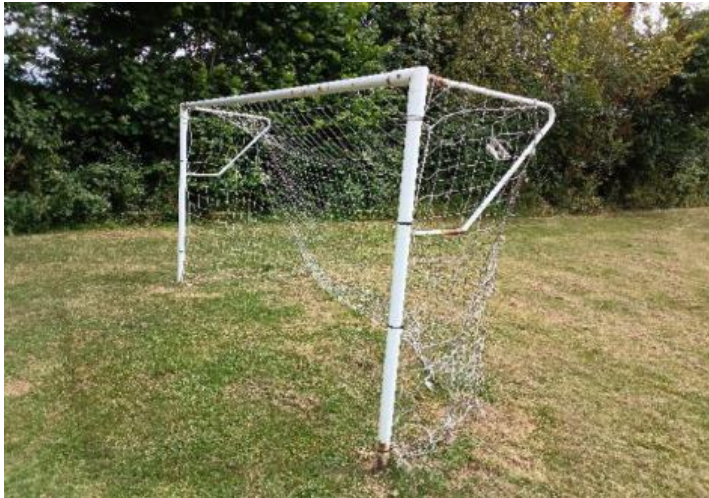
**Finding:** NB: We have undertaken a maintenance inspection only of the football goal(s); full load testing falls outside the scope of our inspection.

**Action:** Implement load testing as required

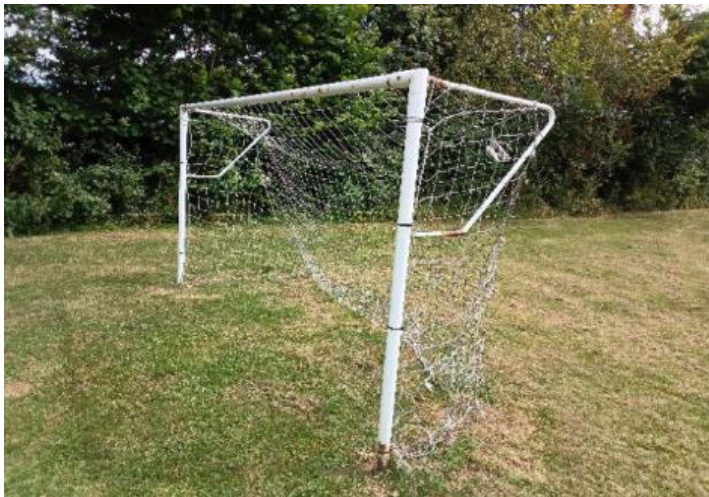
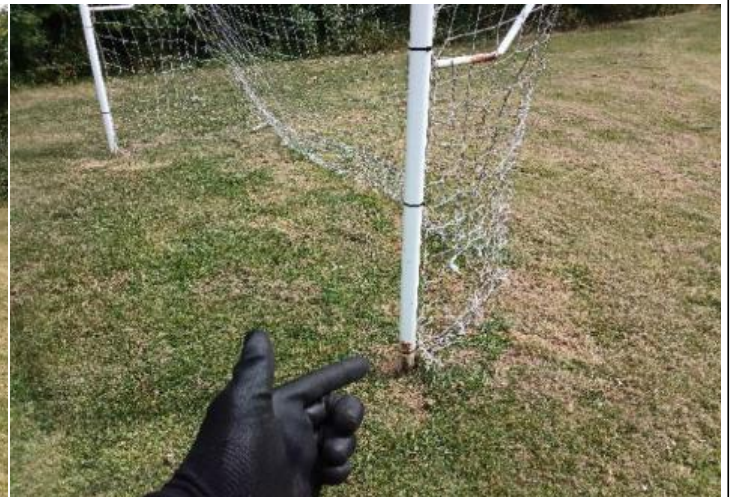
**Finding:** The item is slightly loose in its foundations

**Action:** Monitor for any further deterioration and repair as required

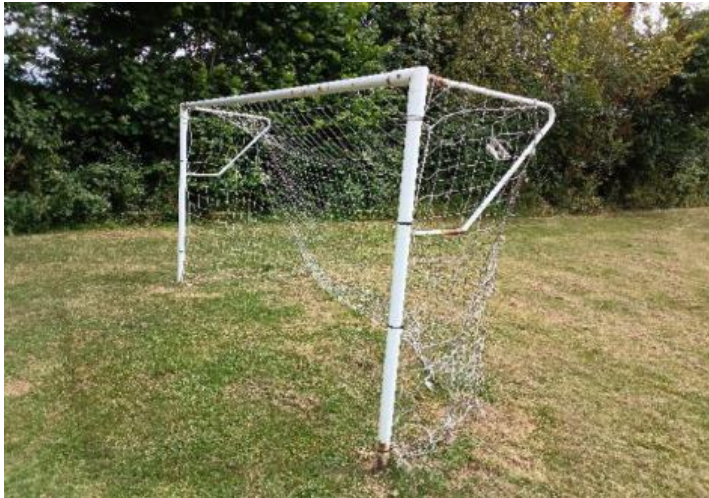
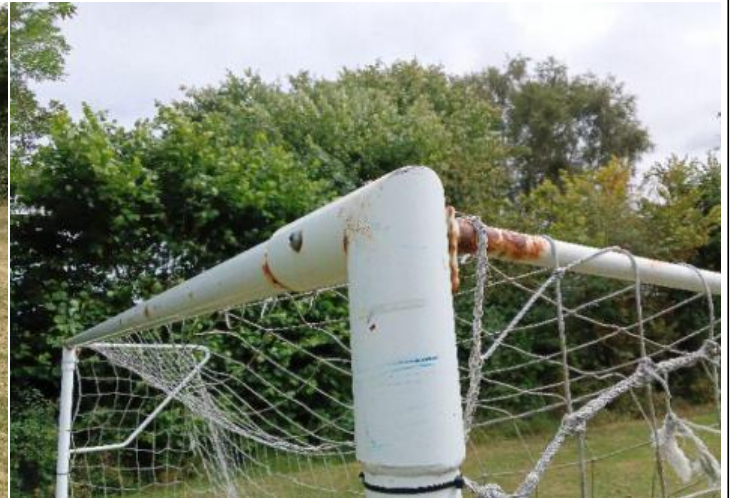
**Finding:** The paintwork on this item has been damaged or worn exposing the metal underneath which is rusting / corroding

**Action:** Treat affected areas and repaint

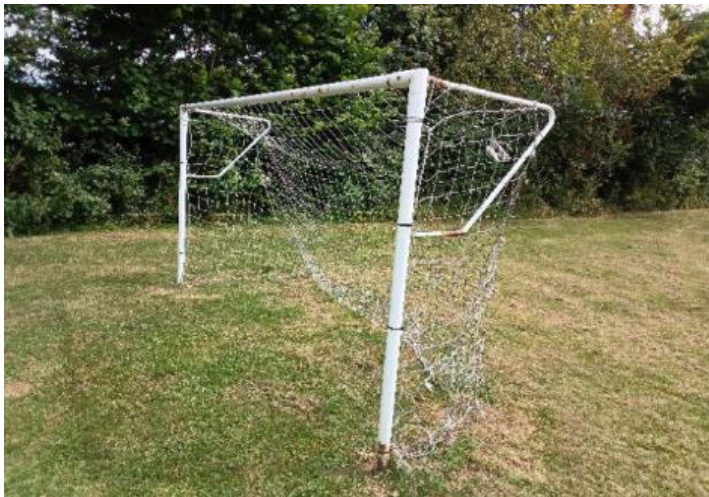
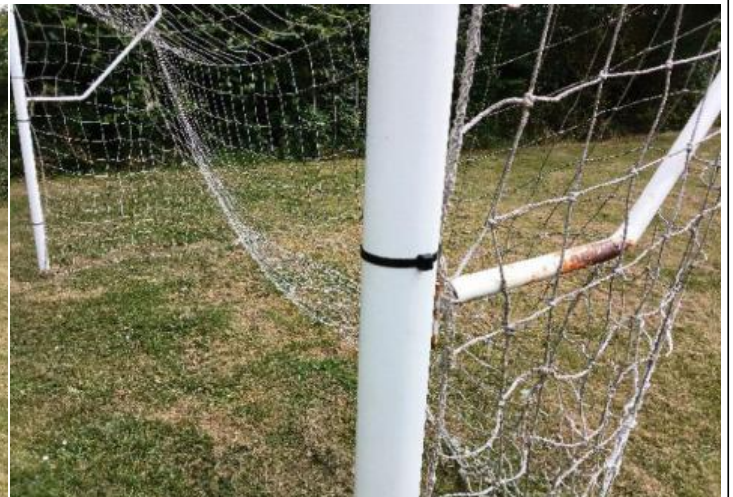
**Finding:** Cable ties have been used on the item and there are sharp projecting ends

**Action:** Remove if not required or replace with a more appropriate alternative fixing method if used as a fixing

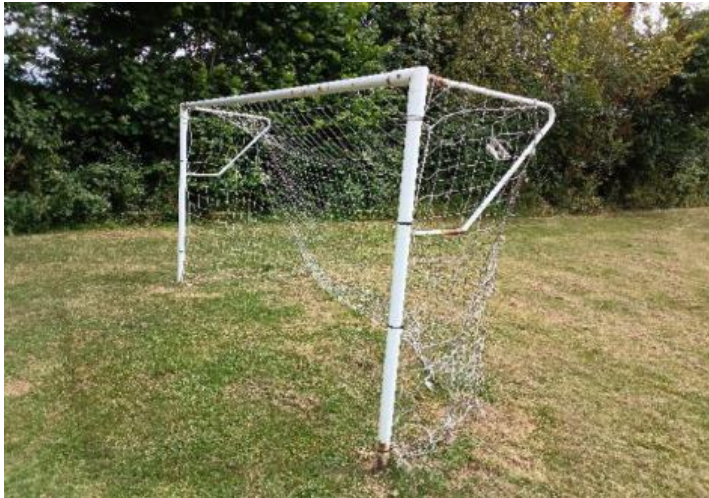
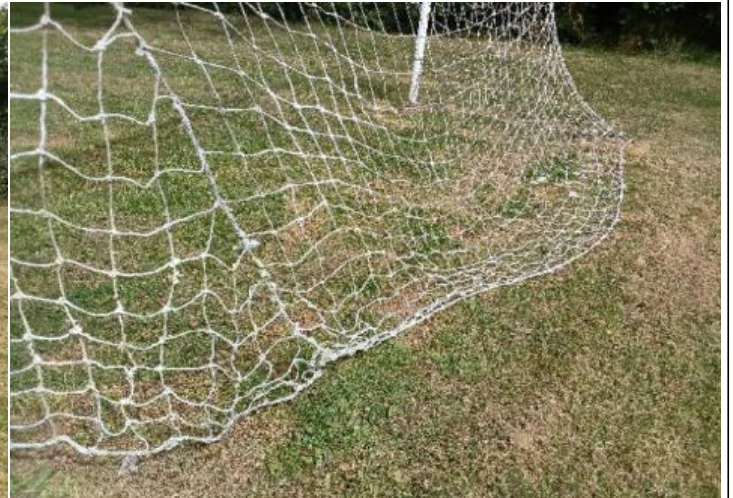
**Finding:** The net is not correctly secured

**Action:** Secure net

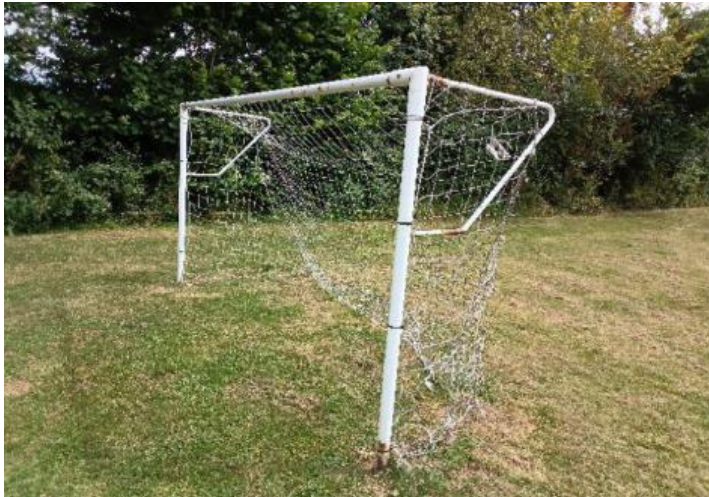
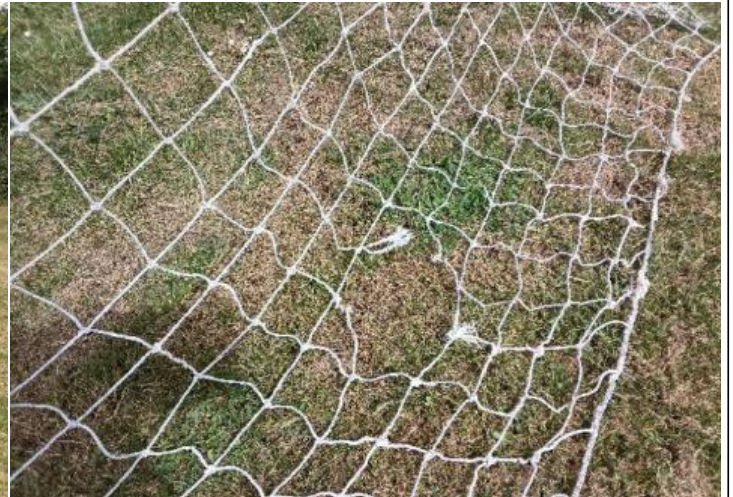
**Finding:** The net is damaged

**Action:** Repair or replace the item / affected part

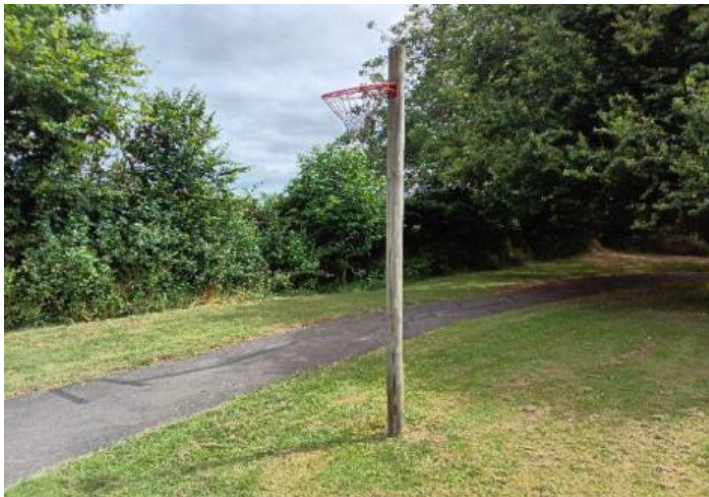
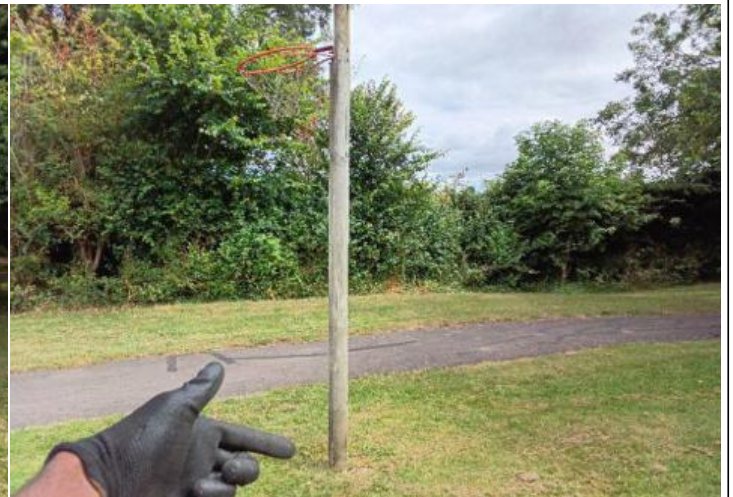
**Finding:** The item is slightly loose in its foundations

**Action:** Monitor for any further deterioration and repair as required

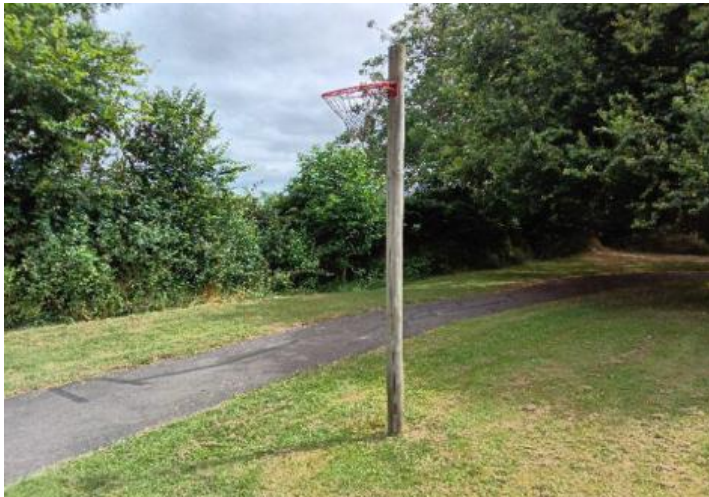
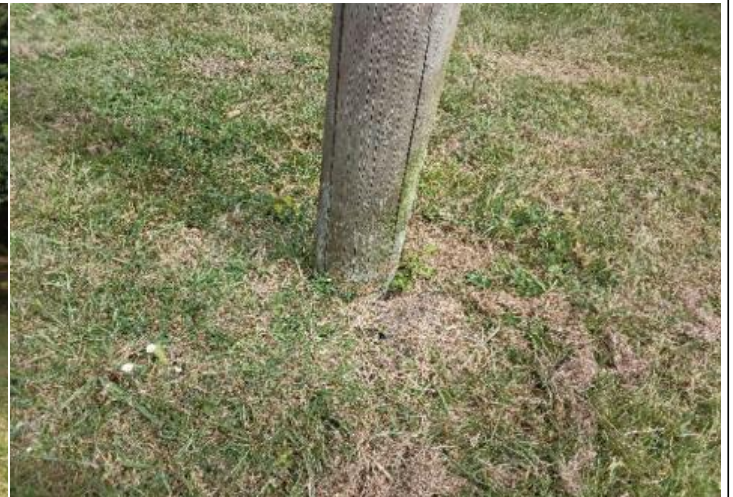
**Finding:** There is some strimmer / machinery damage apparent on the posts, this can penetrate the preservative applied to the timber and accelerate the rotting process

**Action:** Monitor for any deterioration (rot) and replace as required

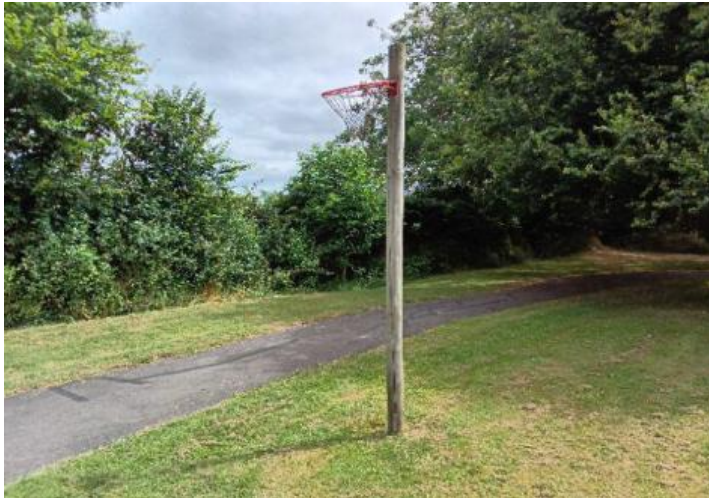
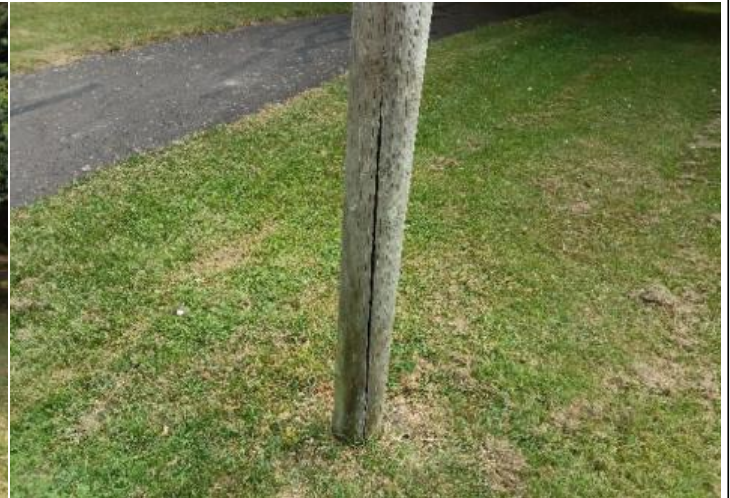
**Finding:** The timber has a number of splits/shakes or air cracks and this may affect the stability or allow water ingress which will accelerate the rotting process  
**Action:** Monitor to ensure the splits do not cross through fixing points of the structure and/or cause any instability

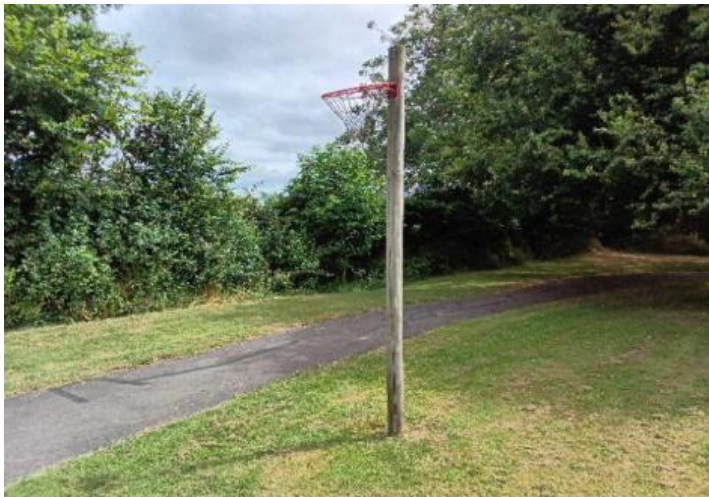
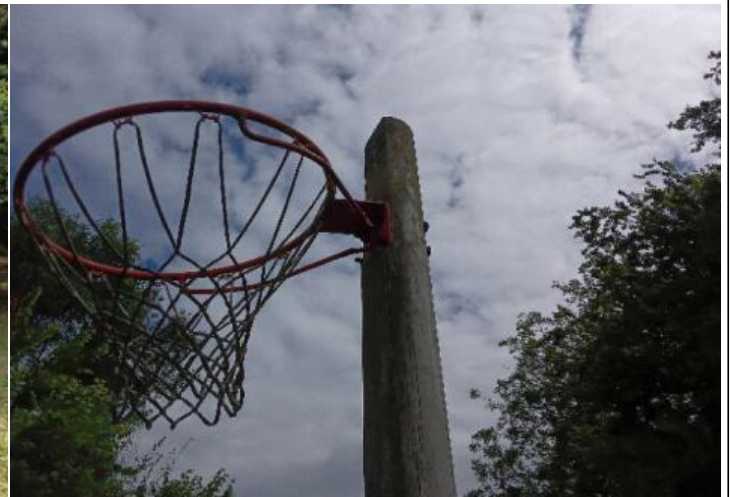
**Finding:** There are projecting bolt thread(s) present  
**Action:** Remove excess thread length and deburr or provide cap

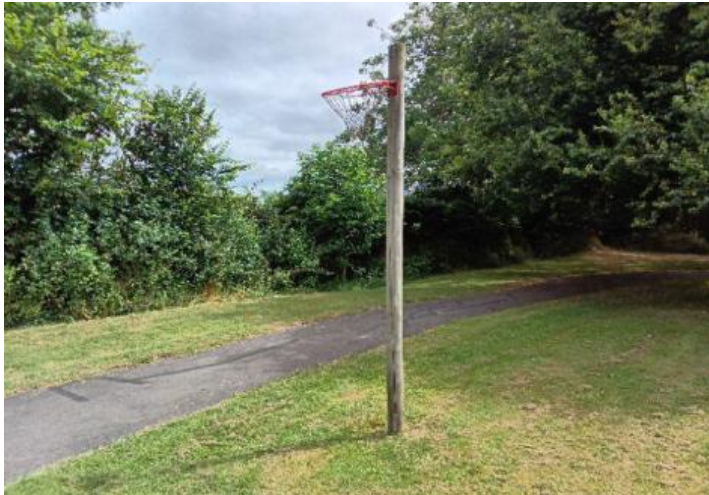
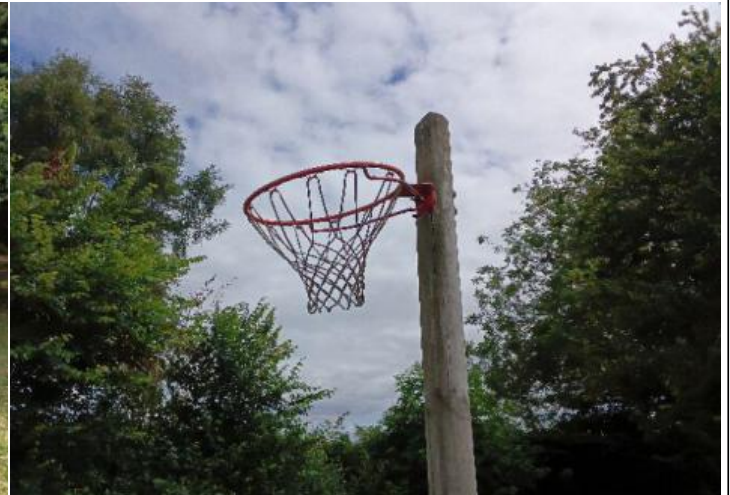
**Finding:** The goal hoops have been damaged or are missing from the equipment

**Action:** Repair or replace as required

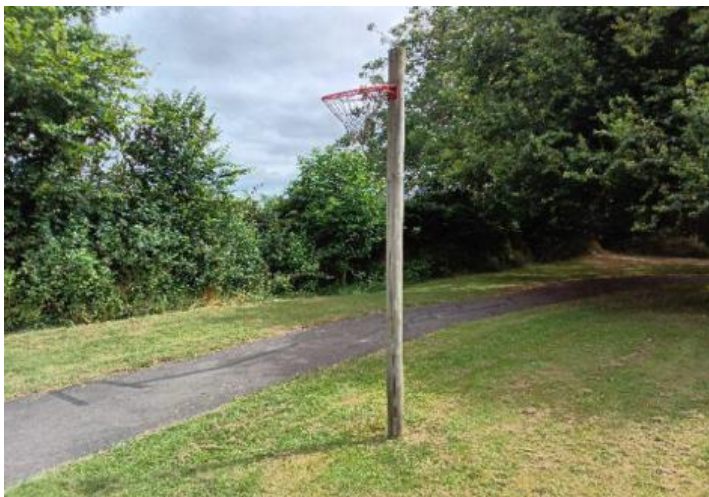
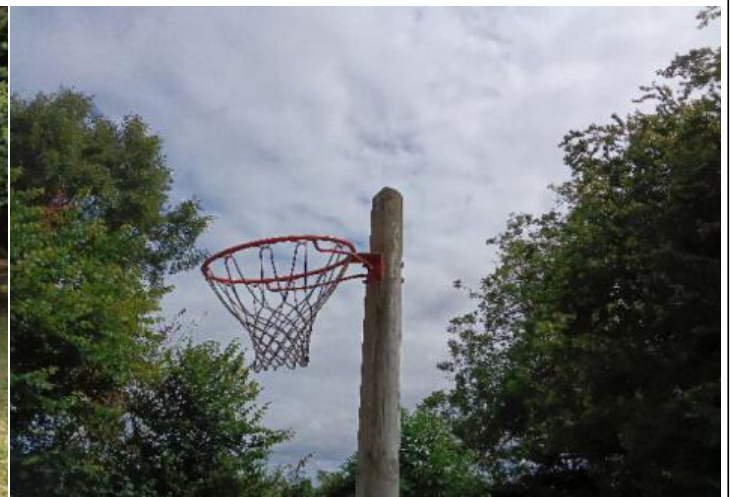
**Finding:** No backboard has been fitted

**Action:** Monitor and provide a backboard if required

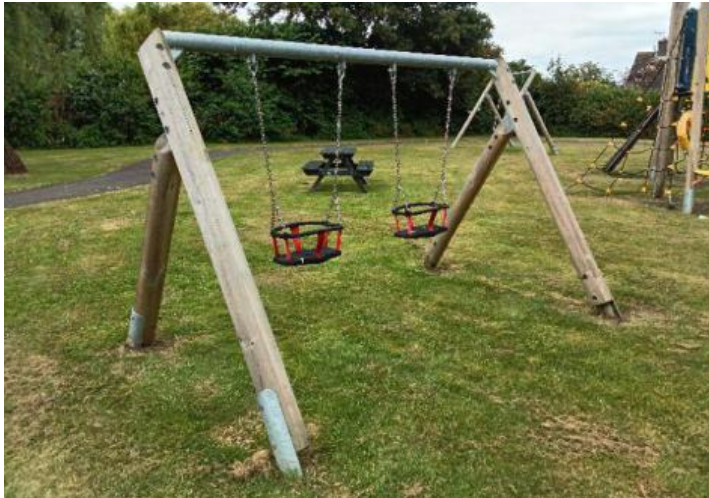
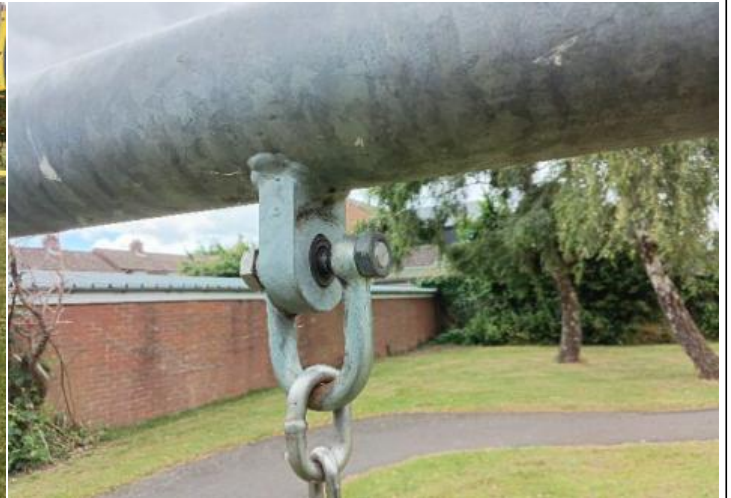
**Finding:** The bushes are showing signs of wear

**Action:** Monitor for any further deterioration and replace as required

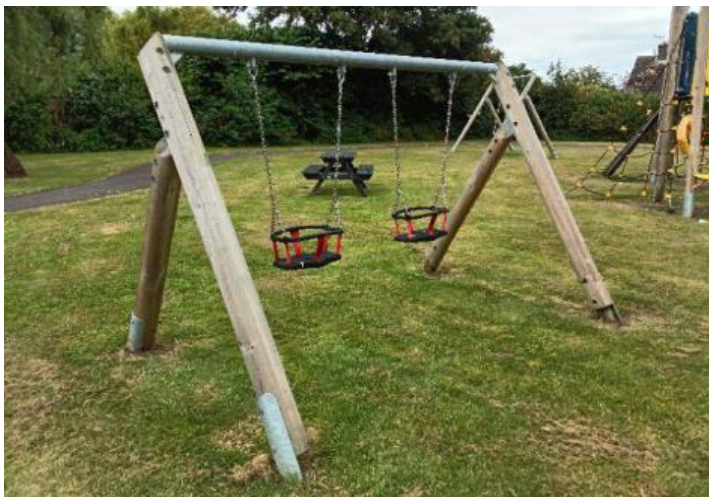
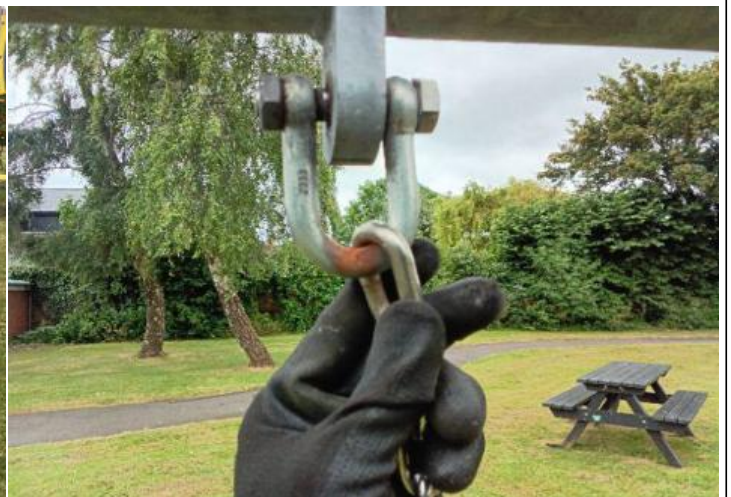
**Finding:** There is some wear to the shackles.

**Action:** Monitor for any further deterioration and replace when 40% worn

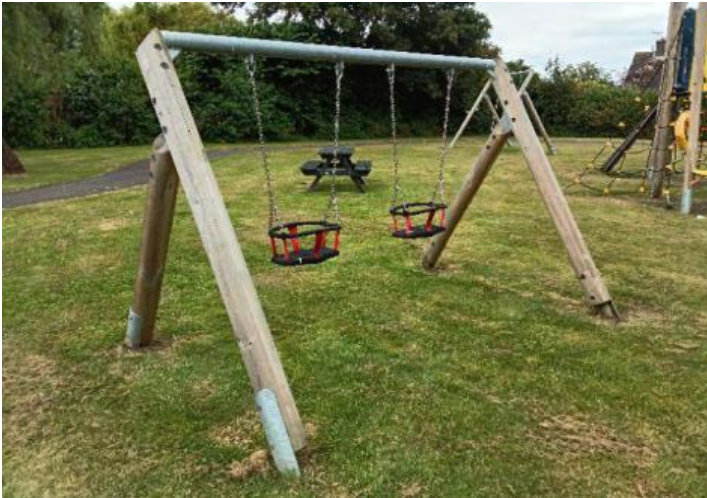
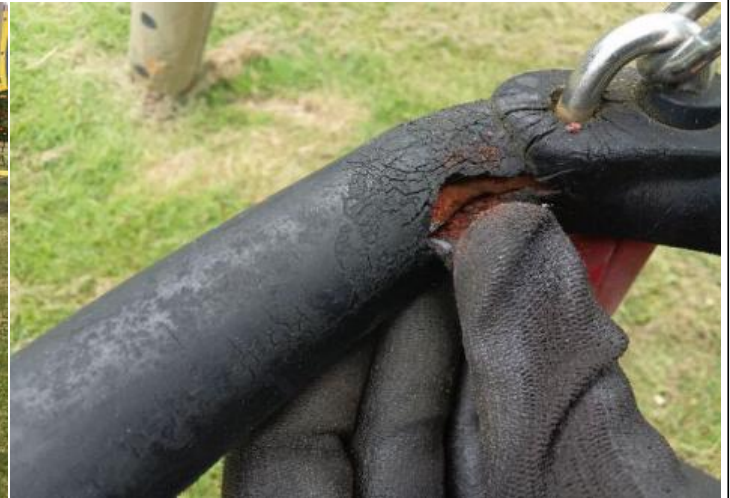
**Finding:** The swing seat frames are corroding

**Action:** Monitor for any further deterioration and replace as required

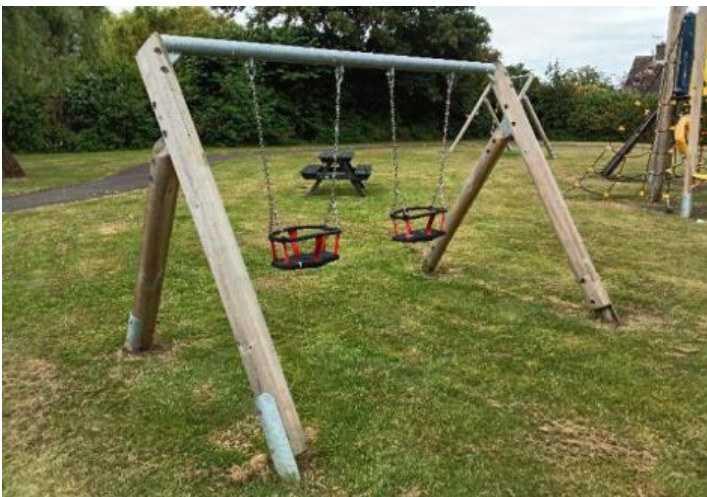
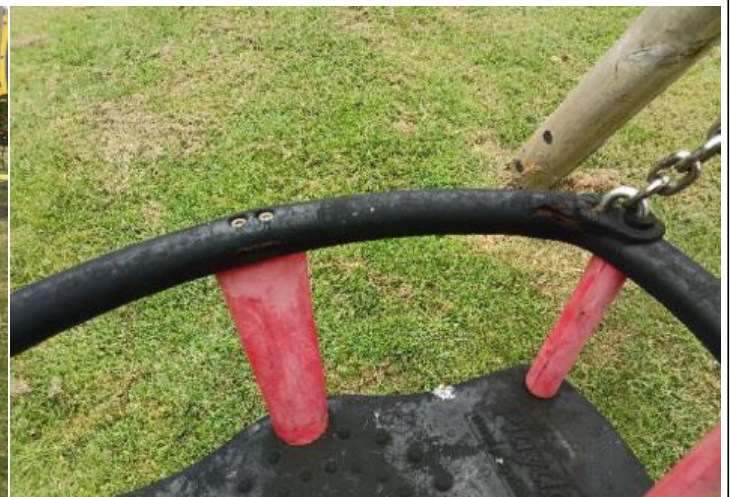
**Finding:** The seat has minor damage or wear

**Action:** Monitor for any further deterioration and replace as required

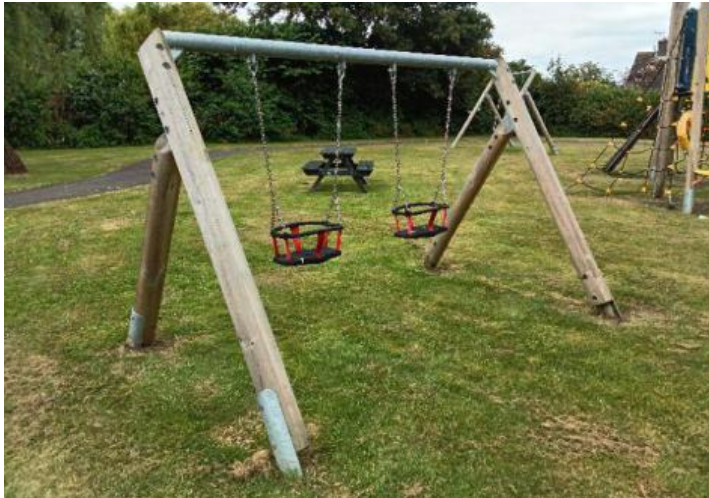
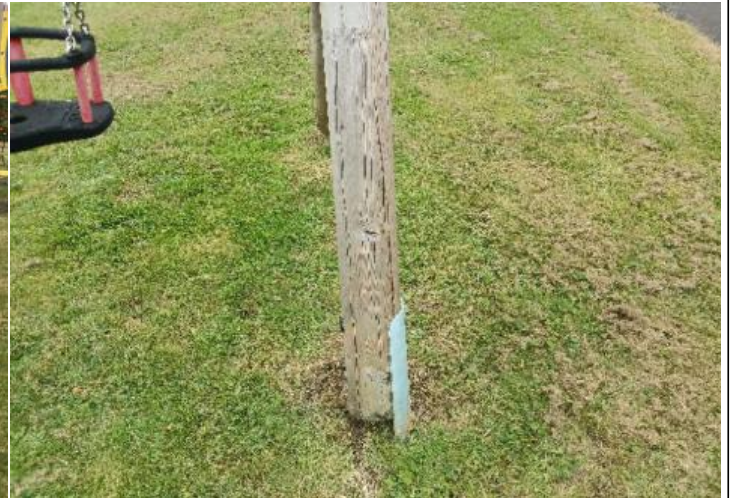
**Finding:** The timber has a number of splits/shakes or air cracks and this may affect the stability or allow water ingress which will accelerate the rotting process  
**Action:** Monitor to ensure the splits do not cross through fixing points of the structure and/or cause any instability

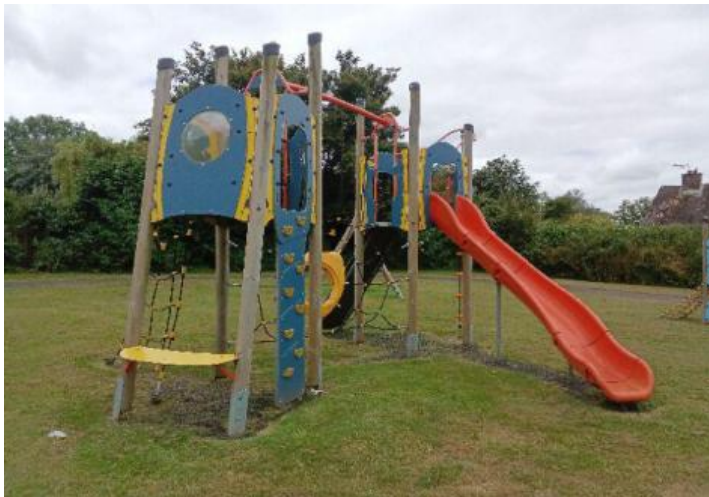
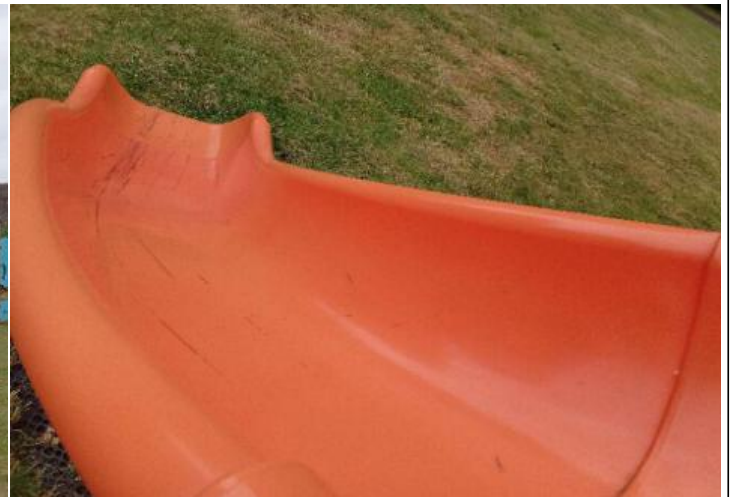
**Finding:** There are a number of dents in the slide surface  
**Action:** Monitor for any further deterioration and repair as required

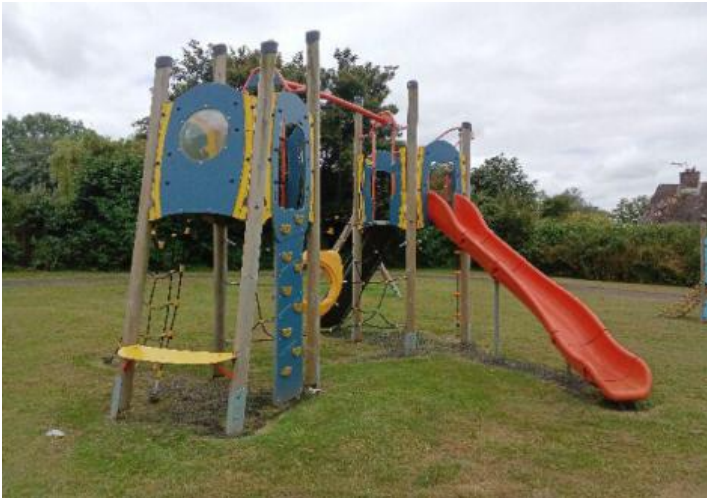
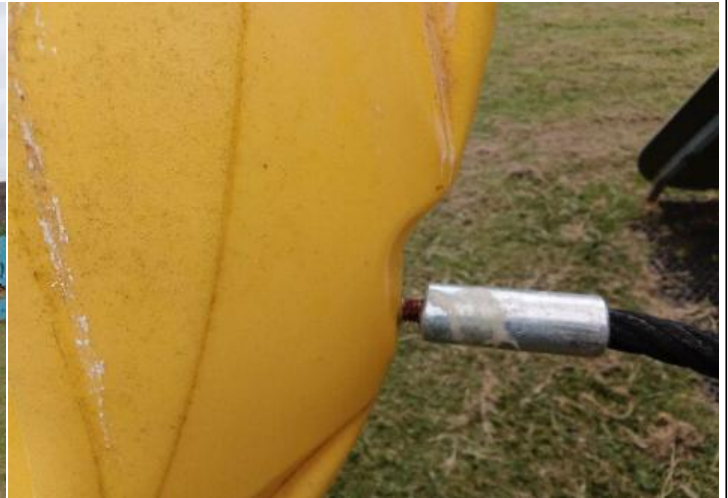
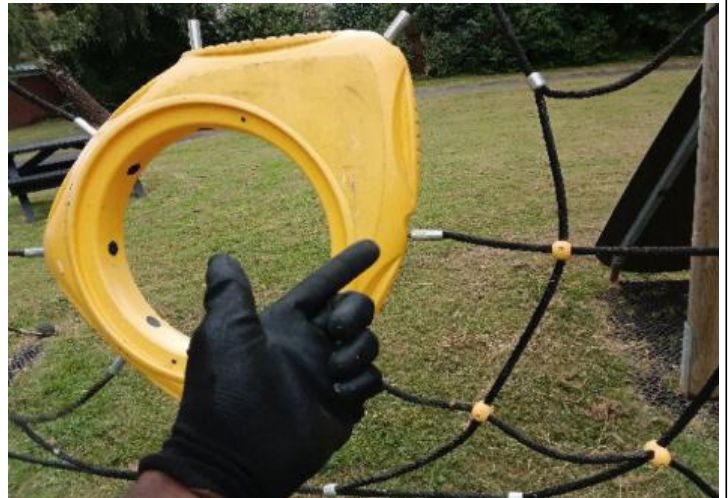
**Finding:** A number of fixing(s) have worked loose

**Action:** Secure all loose fixings

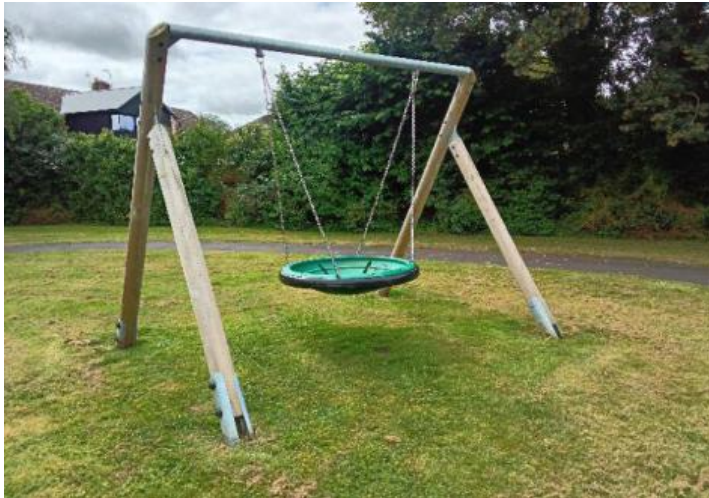
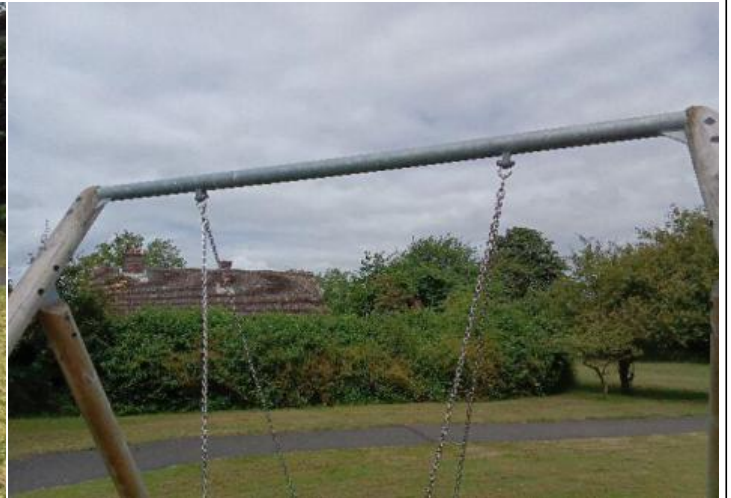
**Finding:** Swings of this design should have a secondary safety mechanism fitted to prevent collapse of the seat in the regularly event of a joint failure to comply with BS EN 1176 Part 2, however this swing was installed prior to the standards being updated in 2018 and the manufacturer has confirmed that the joint was independently cycle tested by BSi

**Action:** Monitor use and check the joint and fixing security

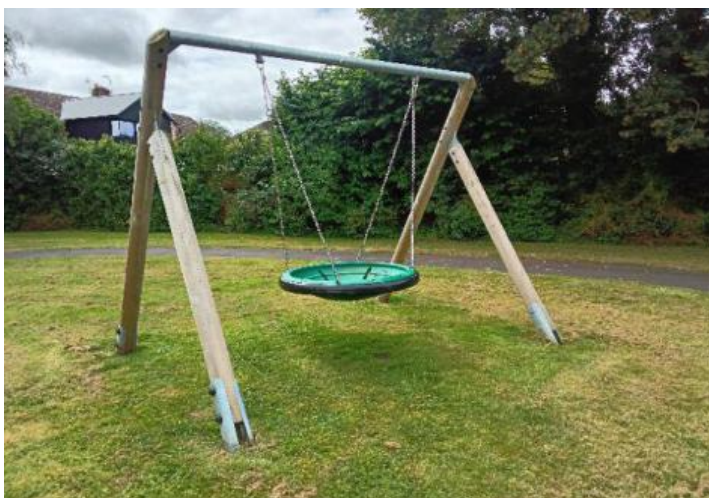
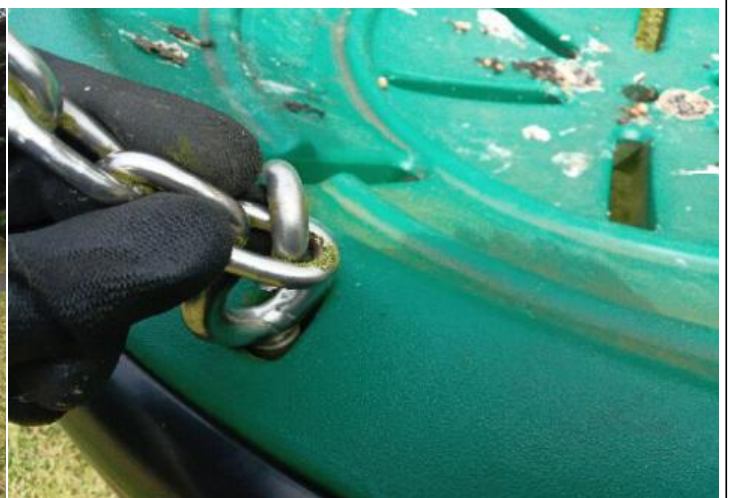
**Finding:** There is some notable evidence of chain wear

**Action:** Monitor for any further deterioration and replace when 40% worn

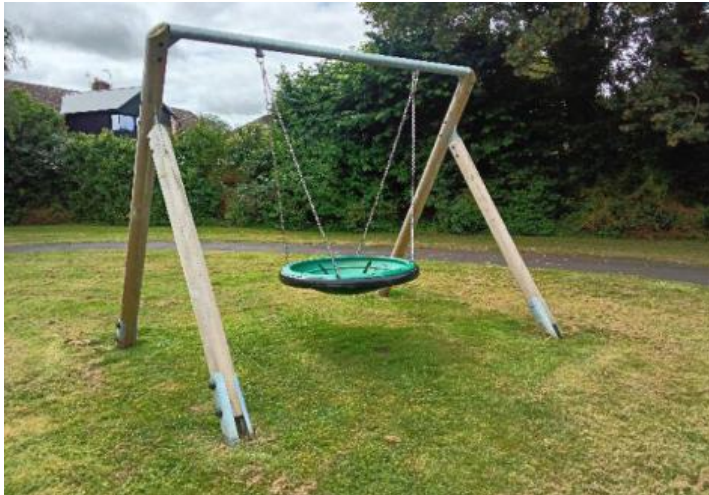
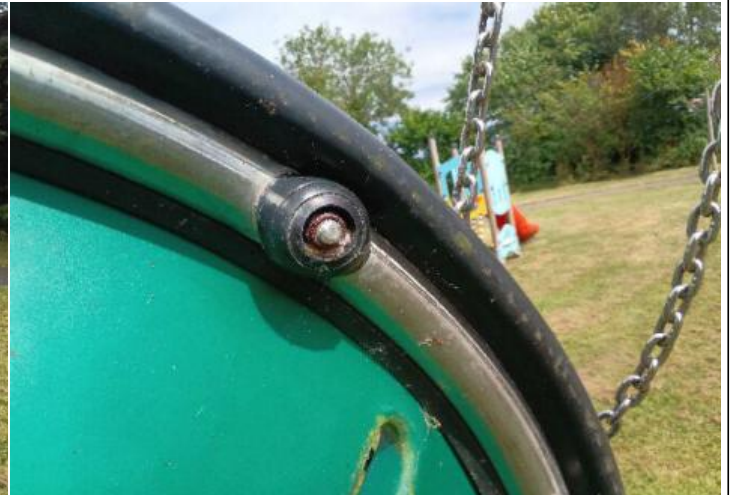
**Finding:** There are caps missing from the underside of the seats

**Action:** Replace missing caps under the seats

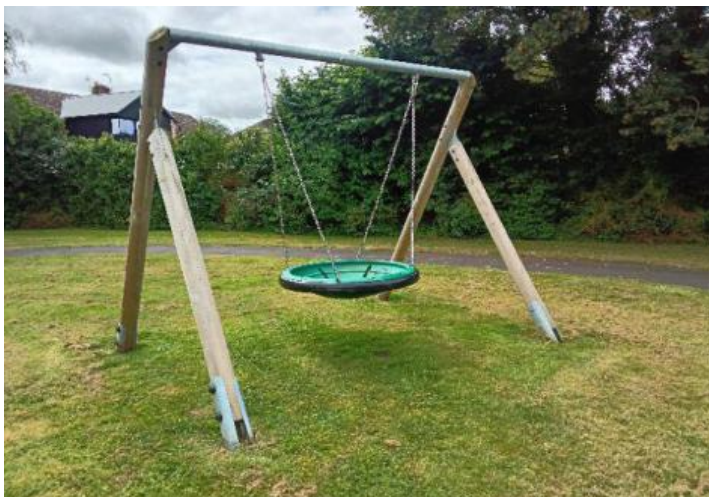
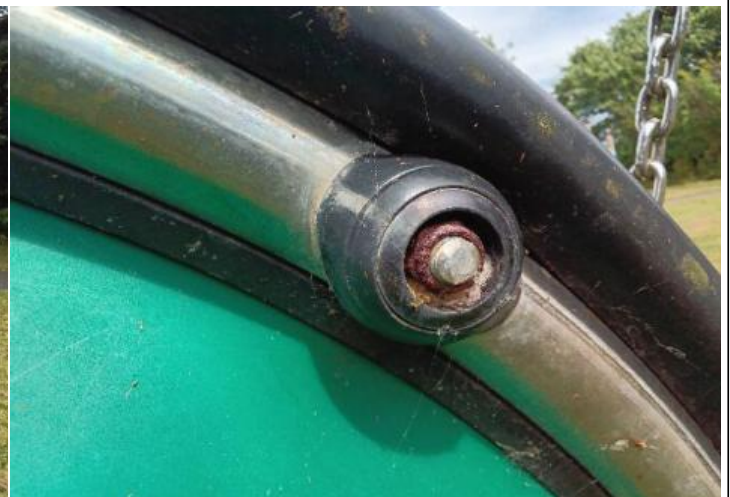
**Finding:** The fixings have corroded excessively

**Action:** Replace all corroded fixings

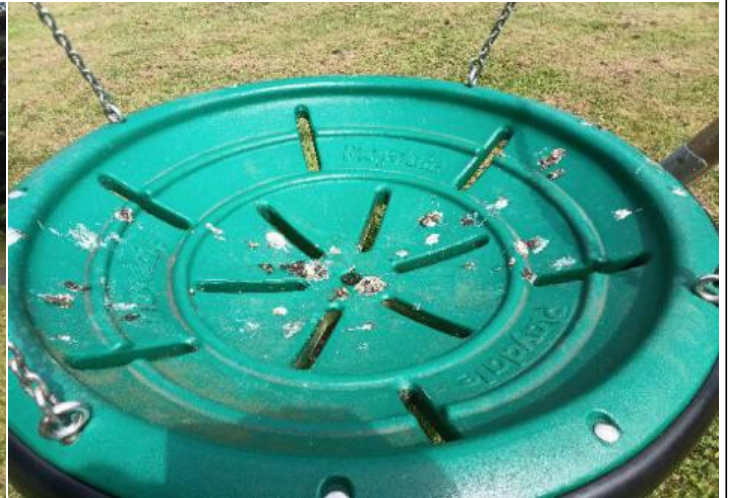
**Finding:** There is excrement on site

**Action:** Clean and maintain area

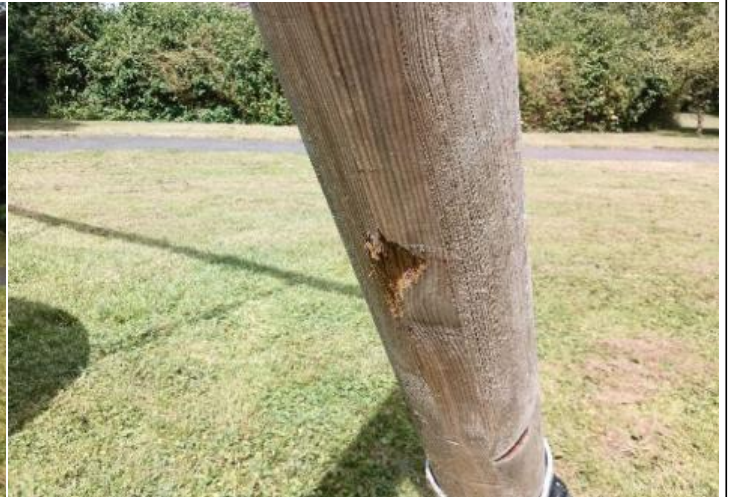
**Finding:** Parts of the timber are rough or splintered

**Action:** Remove all rough or sharp edges
