## Annual Inspection

West Suffolk Parks

Hargrave

Playing Field, School Cottages, off Bury Road,  
Hargrave, IP29 5HR

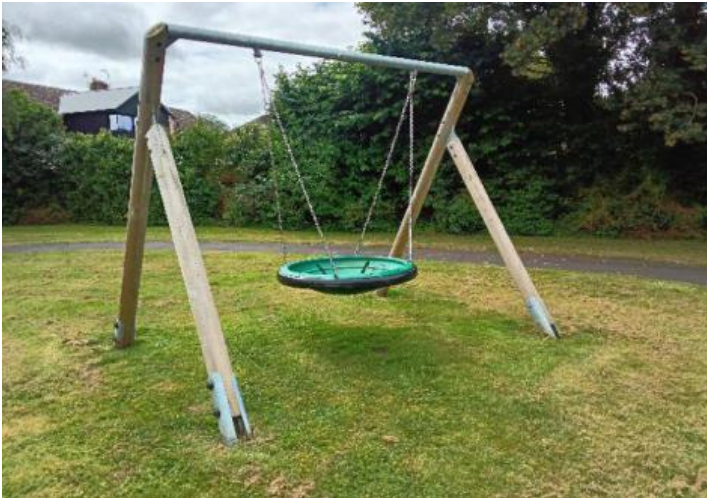
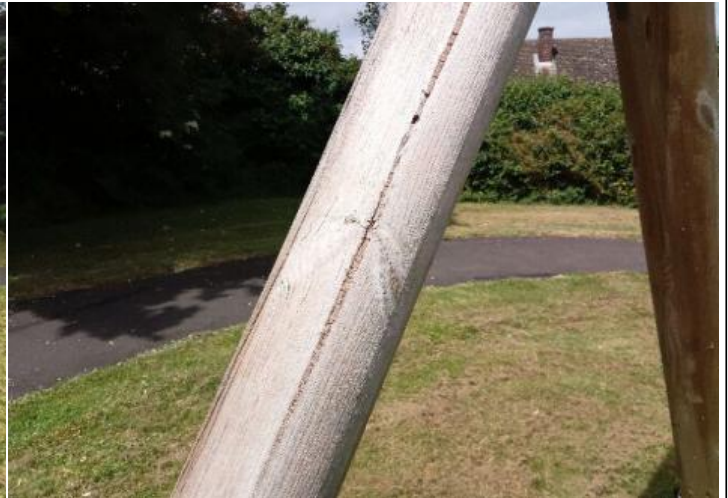
**Finding:** The use of synthetic fillers in timber is not recommended; timber being a natural material will expand and contract as the moisture content changes and the use of fillers can exacerbate the length and depth of these cracks or shakes in the timber. The only treatment that is normally required is the removal of any rough or sharp edges unless the structural integrity of the item is affected.

**Action:** Remove any rough or sharp edges and monitor timber for any further deterioration

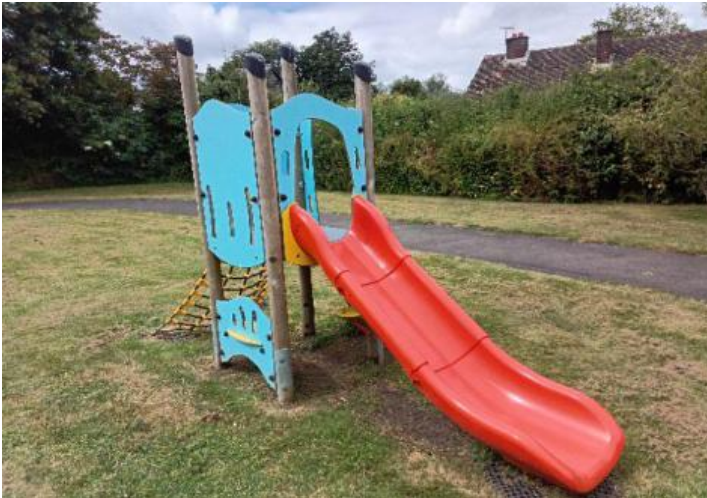
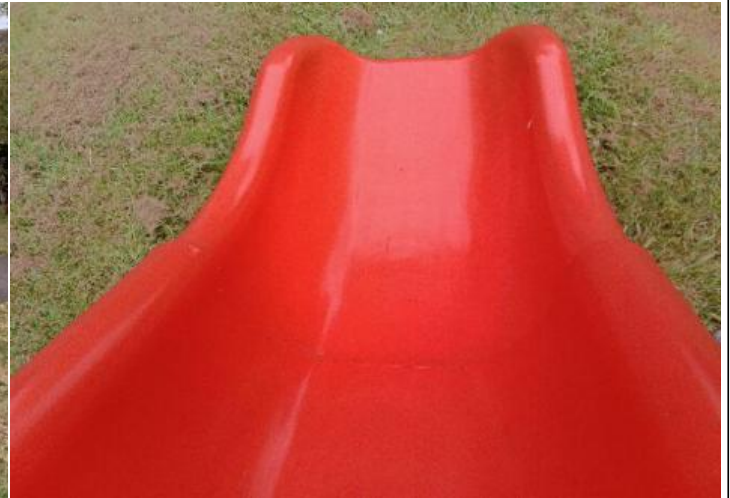
**Finding:** There are a number of dents in the slide surface

**Action:** Monitor for any further deterioration and repair as required

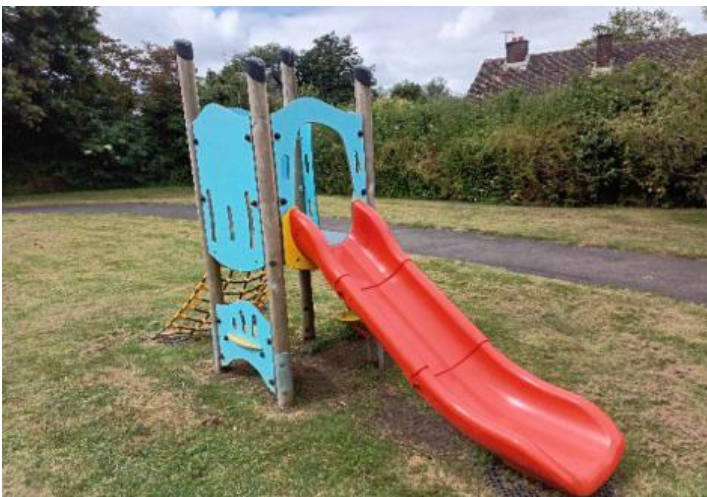
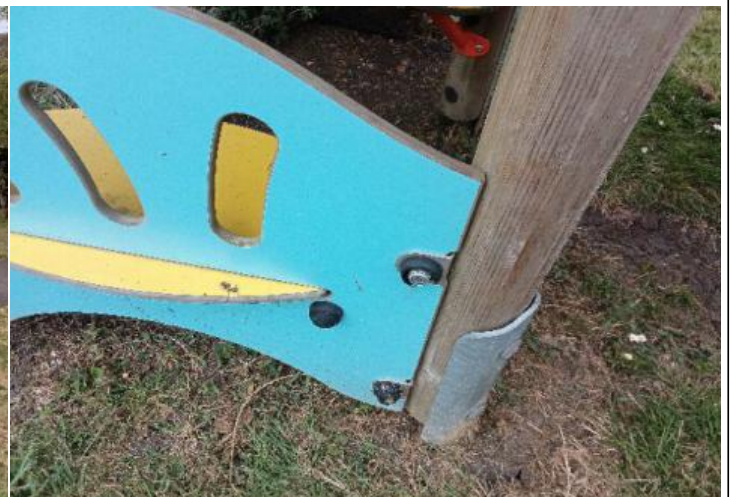
**Finding:** There is/are bolt cap covers missing or damaged on the item

**Action:** Replace missing or damaged bolt cap covers
