## Annual Inspection

West Suffolk Parks

Hargrave

Playing Field, School Cottages, off Bury Road,  
Hargrave, IP29 5HR

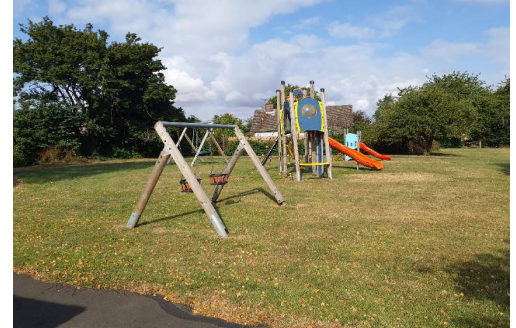
**Item:** Site General  
**Manufacturer:** Owner/Operator  
**Surface Type:** N/A  
**Item Part Number:**  
**Item Quantity:** 1  
**Equipment Compliance:** N/A  
**Surface Area Compliance:** N/A  
**Total Findings:** 2

The grass mats are silted up and the soil is compacted; this may have an effect on the impact absorbing properties of the surface - Consider HIC testing impact absorbing properties to ensure the correct surface qualities are maintained for the equipment and replace as required

There are stress fractures in the tarmac surface - Monitor and repair if required

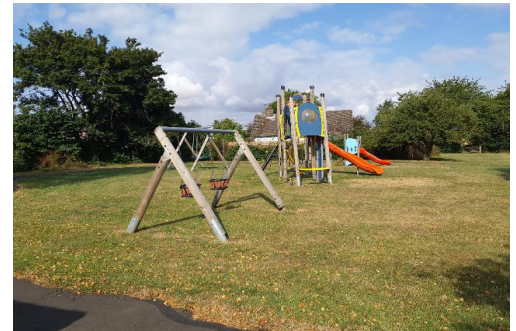
**Item:** Sign  
**Manufacturer:** Not Applicable  
**Surface Type:** N/A  
**Item Quantity:** 1  
**Equipment Compliance:** N/A  
**Surface Area Compliance:** N/A  
**Total Findings:** 1

It is recommended that signage, with information including the site address, contact information for maintenance issues and emergency contact details are provided for the facility - Provide in accordance with the recommendations

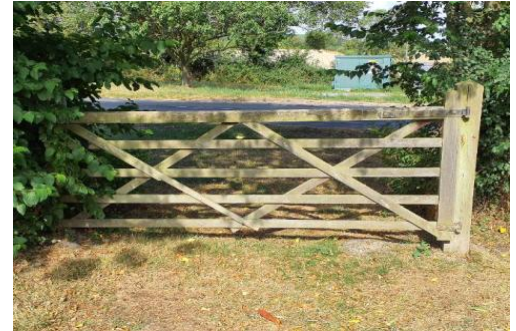
**Item:** Gate - Maintenance  
**Manufacturer:** Not Identified  
**Surface Type:** Grass  
**Item Quantity:** 1  
**Equipment Compliance:** N/A  
**Surface Area Compliance:** N/A

There are projecting bolt thread(s) present - Remove excess thread length and deburr or provide cap

The surface has eroded and the foundations are exposed - Reinstate surrounding surfaces to cover the foundations

There is an old post socket under the gate - Remove the concrete and reinstate to provide a uniform surface

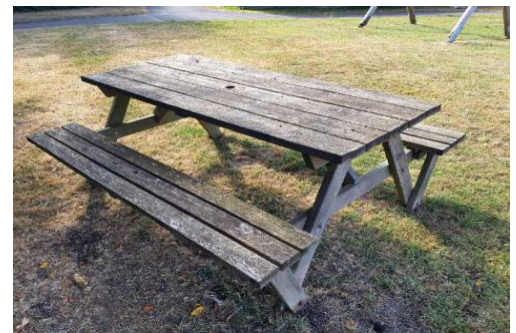
**Item:** Picnic Table  
**Manufacturer:** Unknown  
**Surface Type:** Grass  
**Item Part Number:**  
**Item Quantity:** 1  
**Equipment Compliance:** N/A  
**Surface Area Compliance:** N/A  
**Total Findings:** 2

The table/s is/are not secured to the ground and there is some potential for the item/s to be moved within falling spaces of equipment - Secure to the ground

There is algae or moss on the surface of the bench - Clean and treat appropriately

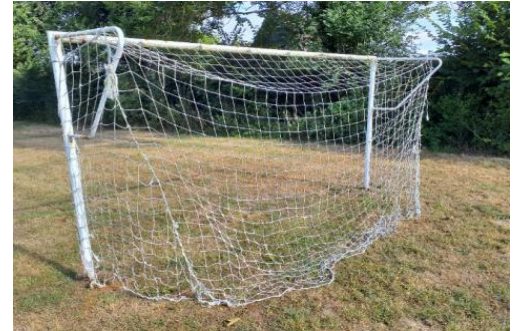
**Item:** Football Goal  
**Manufacturer:** Unknown  
**Surface Type:** Grass  
**Item Quantity:** 1  
**Equipment Compliance:** N/A  
**Surface Area Compliance:** N/A

NB: We have undertaken a maintenance inspection only of the football goal(s); full load testing falls outside the scope of our inspection. - Implement load testing as required

The net is damaged - Replace the damaged net

The paintwork on this item has been damaged or worn exposing the metal underneath which is rusting - Treat any rusting components and repaint

The net is not secured correctly - Refer to the manufacturers specification and rectify

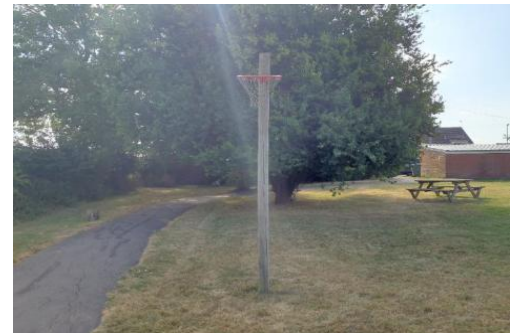
**Item:** Basketball Post  
**Manufacturer:** Owner/Operator  
**Surface Type:** Grass  
**Item Quantity:** 1  
**Equipment Compliance:** No  
**Surface Area Compliance:** N/A

The timber has a number of splits/shakes or air cracks and this may affect the stability or allow water ingress which will accelerate the rotting process - Monitor to ensure the splits do not cross through fixing points of the structure and/or cause any instability

There is some strimmer / machinery damage apparent on the posts, this can penetrate the preservative applied to the timber and accelerate the rotting process - Monitor for any deterioration (rot) and replace as required

The item is slightly loose in its foundations - Monitor for any further deterioration and repair as required

A number of fixing(s) have worked loose - Secure all loose fixings

No backboard has been fitted - Monitor and provide a backboard if required

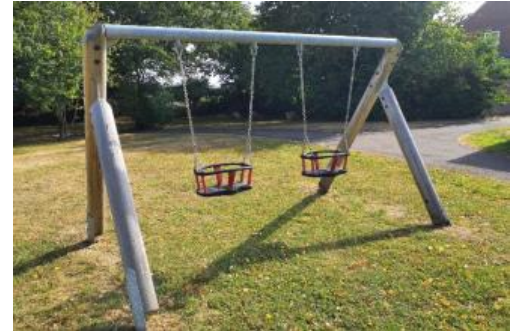
**Item:** 1 Bay 2 Seat (Cradle)  
**Manufacturer:** Playdale Playgrounds Ltd  
**Surface Type:** Grass Matrix Tiles  
**Item Quantity:** 1  
**Equipment Compliance:** Yes  
**Surface Area Compliance:** Yes

This item is satisfactory - no work required -

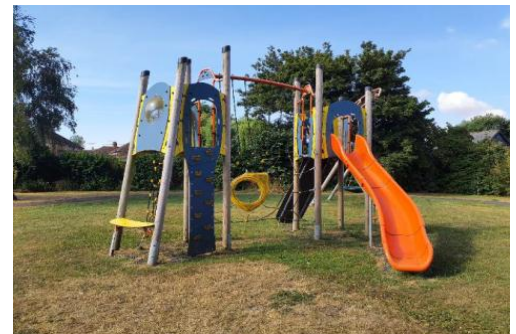
**Item:** Multi Play (Senior)  
**Manufacturer:** Playdale Playgrounds Ltd  
**Surface Type:** Grass Matrix Tiles  
**Item Quantity:** 1  
**Equipment Compliance:** Yes  
**Surface Area Compliance:** Yes

There is algae or moss on the surface of the equipment - Clean and treat appropriately

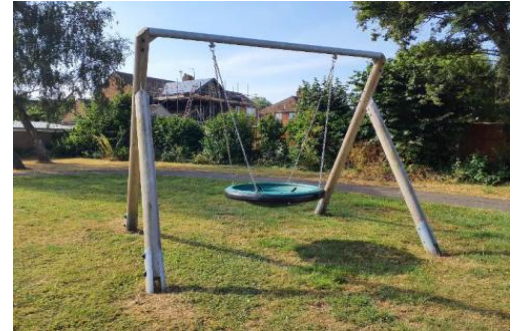
**Item:** Basket Swing - Type 1  
**Manufacturer:** Playdale Playgrounds Ltd  
**Surface Type:** Grass Matrix Tiles  
**Item Quantity:** 1  
**Equipment Compliance:** No  
**Surface Area Compliance:** Yes

Swings of this design should have a secondary safety mechanism fitted to prevent collapse of the seat in the event of a joint failure to comply with BS EN 1176 Part 2, however this swing was installed prior to the standards being updated in 2018 and the manufacturer has confirmed that the joint was independently cycle tested by BSi - Monitor use and check the joint and fixing security regularly

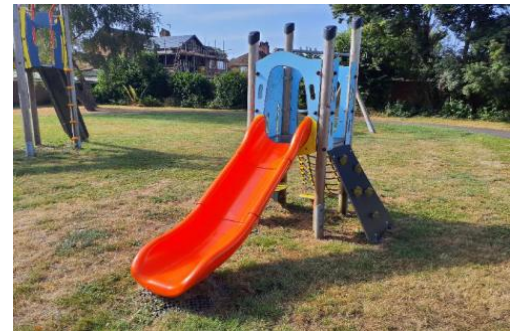
**Item:** Multi Play (Junior)  
**Manufacturer:** Playdale Playgrounds Ltd  
**Surface Type:** Grass Matrix Tiles  
**Item Quantity:** 1  
**Equipment Compliance:** Yes  
**Surface Area Compliance:** Yes

There is/are bolt cap covers missing or damaged on the item - Replace missing or damaged bolt cap covers

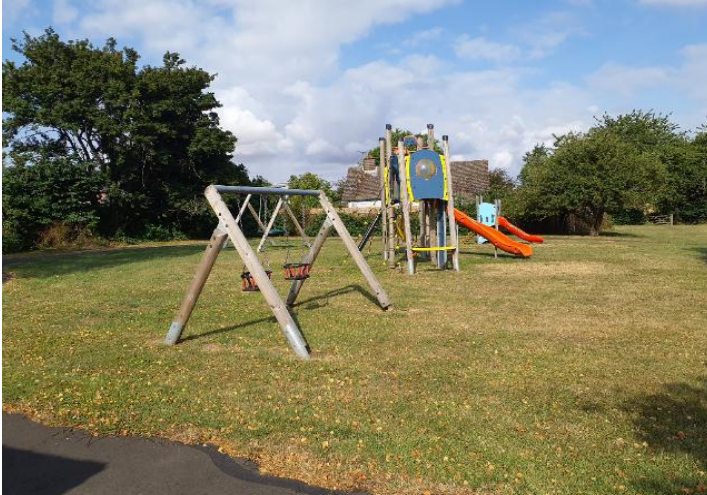
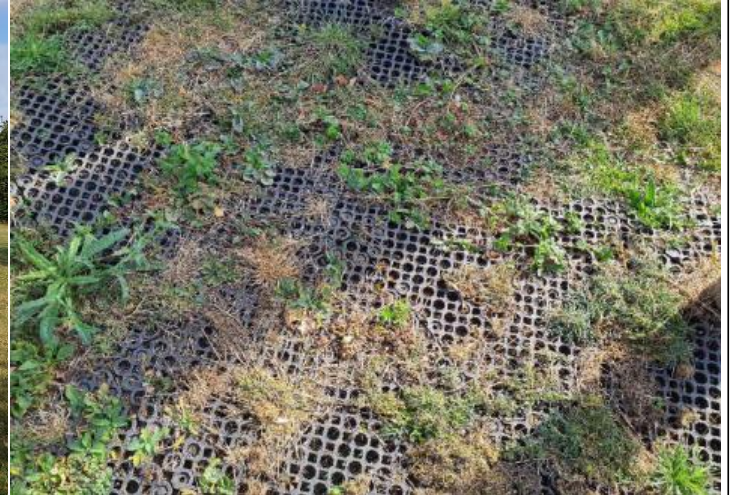
**Item:** Ancillary Items - Site General  
**Manufacturer:** Owner/Operator

**Finding:** The grass mats are silted up and the soil is compacted; this may have an effect on the impact absorbing properties of the surface

**Action:** Consider HIC testing impact absorbing properties to ensure the correct surface qualities are maintained for the equipment and replace as required

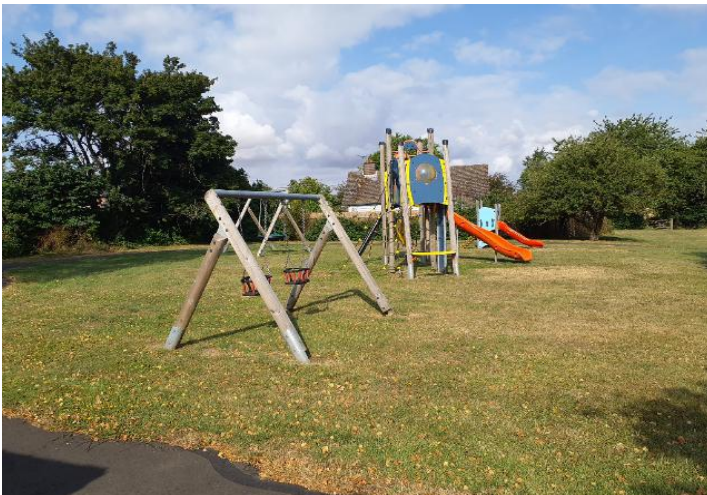
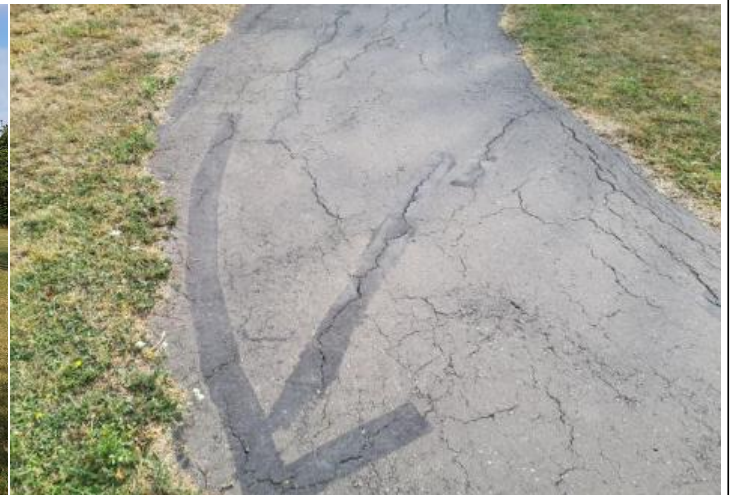
**Item:** Ancillary Items - Site General  
**Manufacturer:** Owner/Operator

**Finding:** There are stress fractures in the tarmac surface

**Action:** Monitor and repair if required

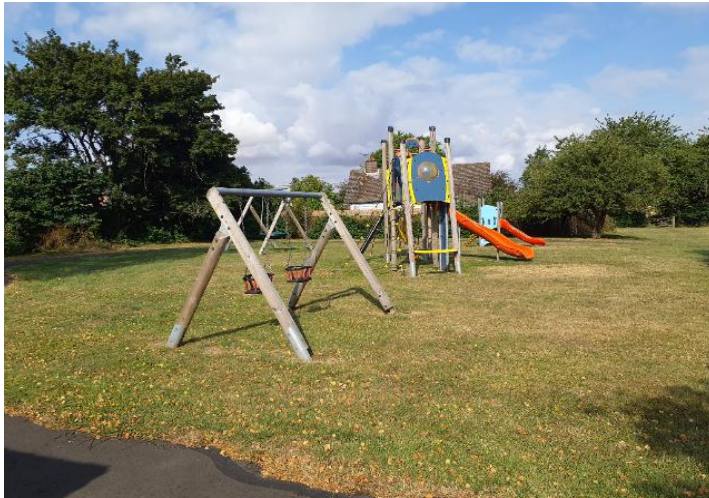
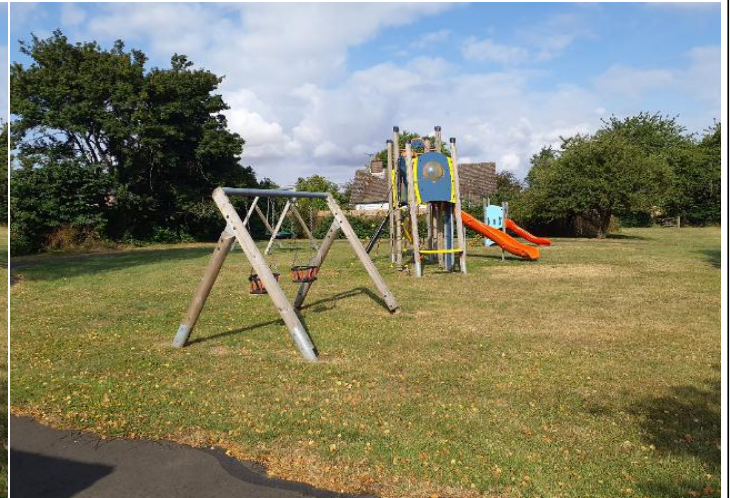
**Item:** Ancillary Items - Sign  
**Manufacturer:** Not Applicable

**Finding:** It is recommended that signage, with information including the site address, contact information for maintenance issues and emergency contact details are provided for the facility

**Action:** Provide in accordance with the recommendations

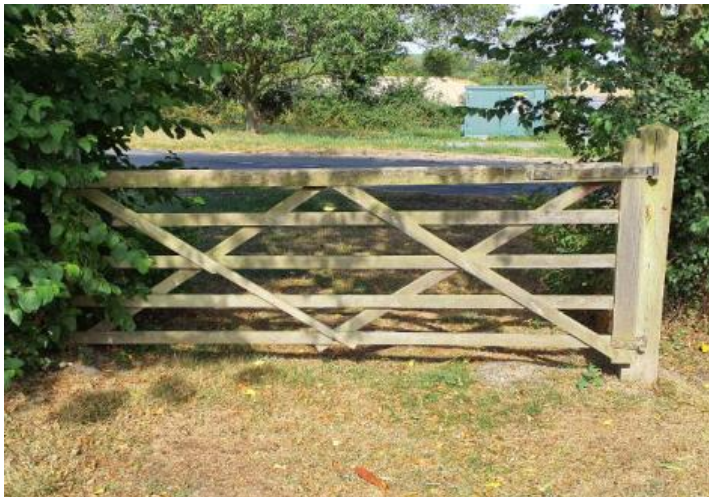
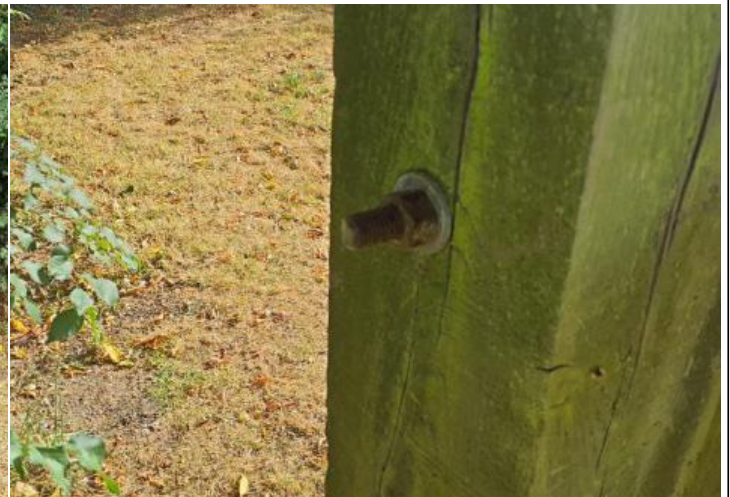
**Item:** Gates - Gate - Maintenance  
**Manufacturer:** Not Identified

**Finding:** There are projecting bolt thread(s) present

**Action:** Remove excess thread length and deburr or provide cap

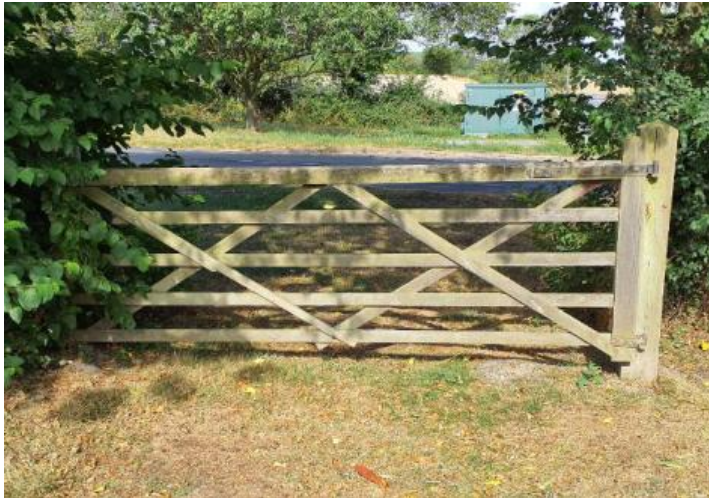
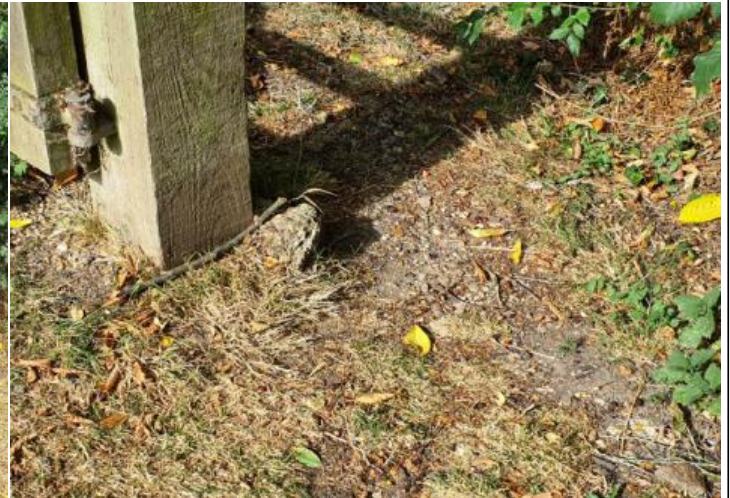
**Item:** Gates - Gate - Maintenance  
**Manufacturer:** Not Identified

**Finding:** The surface has eroded and the foundations are exposed

**Action:** Reinstate surrounding surfaces to cover the foundations

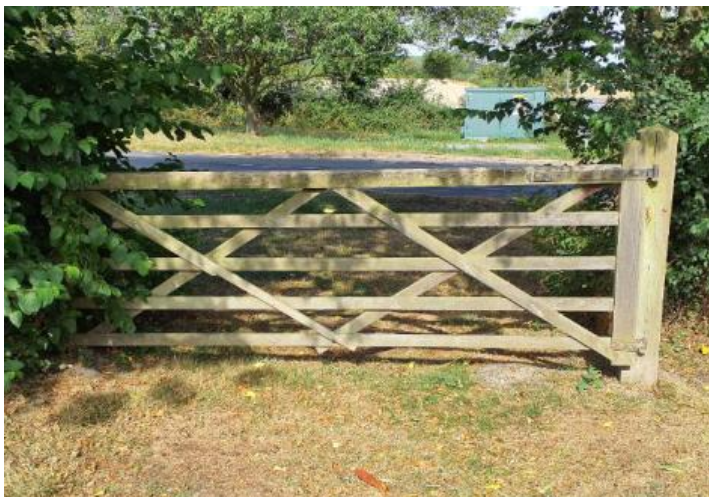
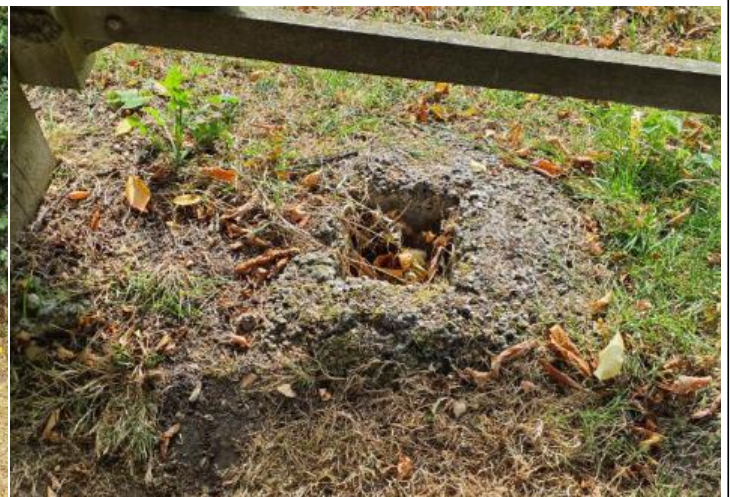
**Item:** Gates - Gate - Maintenance  
**Manufacturer:** Not Identified

**Finding:** There is an old post socket under the gate

**Action:** Remove the concrete and reinstate to provide a uniform surface

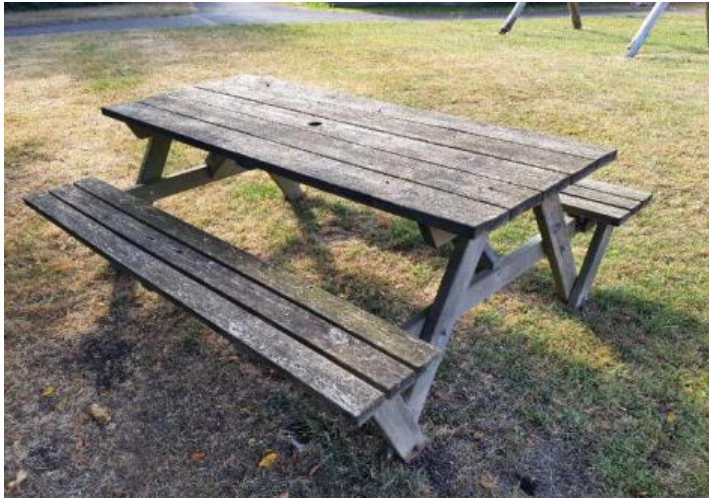
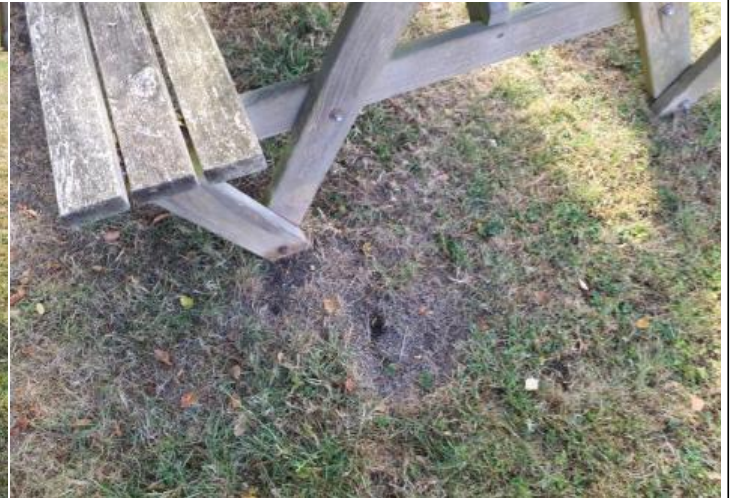
**Item:** Ancillary Items - Picnic Table  
**Manufacturer:** Unknown

**Finding:** The table/s is/are not secured to the ground and there is some potential for the item/s to be moved within falling spaces of equipment

**Action:** Secure to the ground

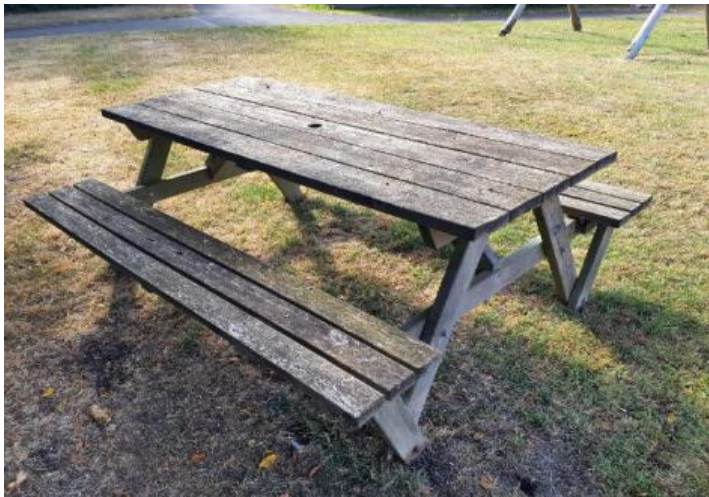
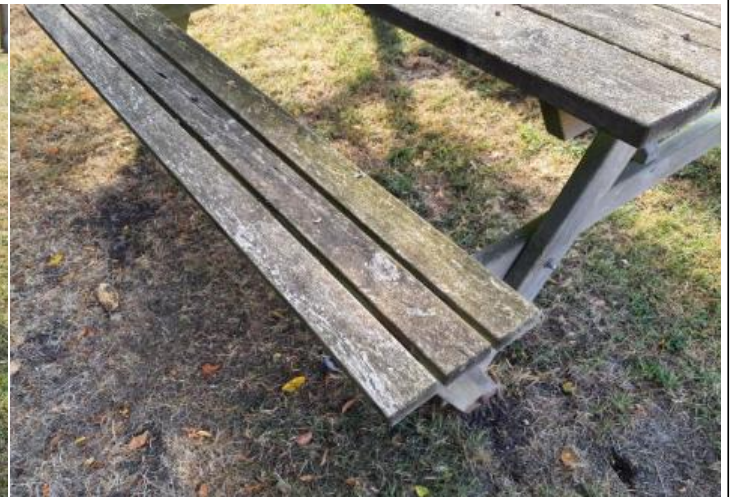
**Item:** Ancillary Items - Picnic Table  
**Manufacturer:** Unknown

**Finding:** There is algae or moss on the surface of the bench **Action:** Clean and treat appropriately

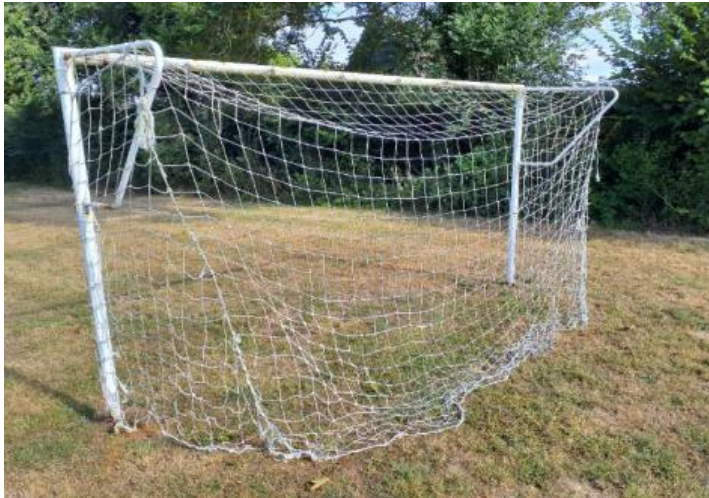
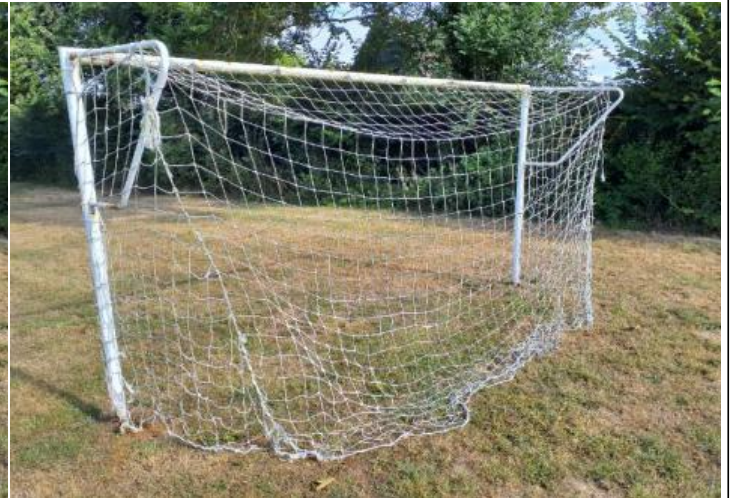
**Item:** Multi Use Games Area - Football Goal  
**Manufacturer:** Unknown

**Finding:** NB: We have undertaken a maintenance inspection only of the football goal(s); full load testing falls outside the scope of our inspection.

**Action:** Implement load testing as required

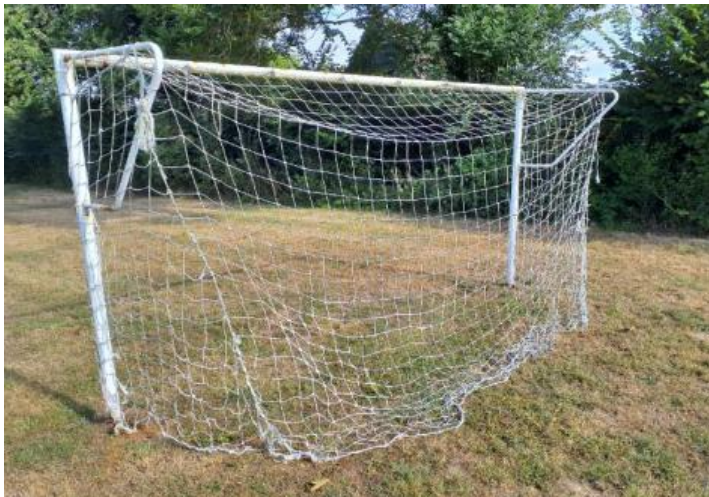
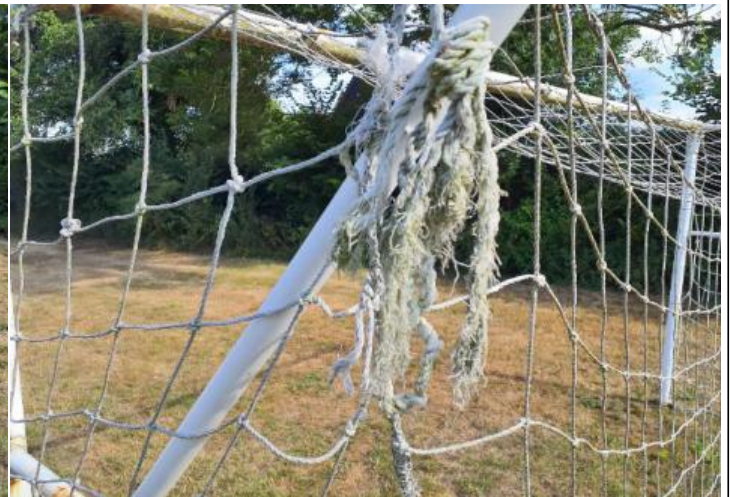
**Item:** Multi Use Games Area - Football Goal  
**Manufacturer:** Unknown

**Finding:** The net is damaged

**Action:** Replace the damaged net

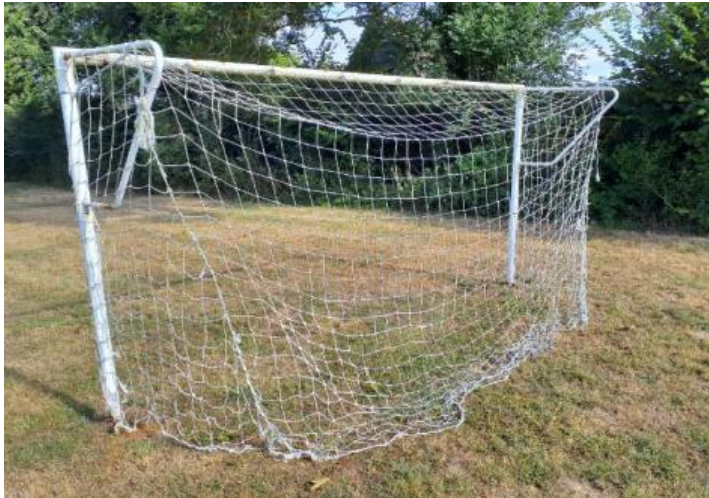
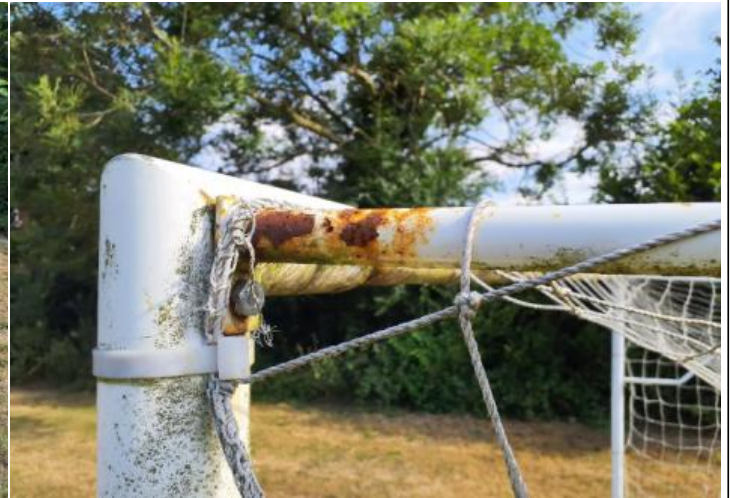
**Item:** Multi Use Games Area - Football Goal  
**Manufacturer:** Unknown  
**Risk Level:** L - Low Risk  
**Surface:** Grass

**Finding:** The paintwork on this item has been damaged or worn exposing the metal underneath which is rusting  
**Action:** Treat any rusting components and repaint

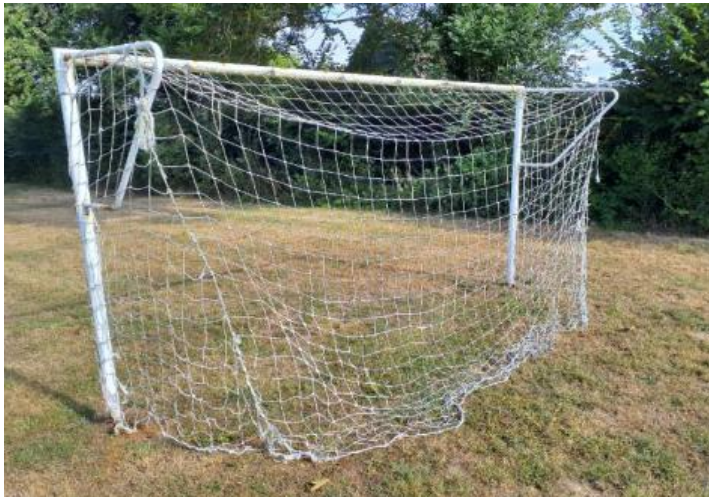
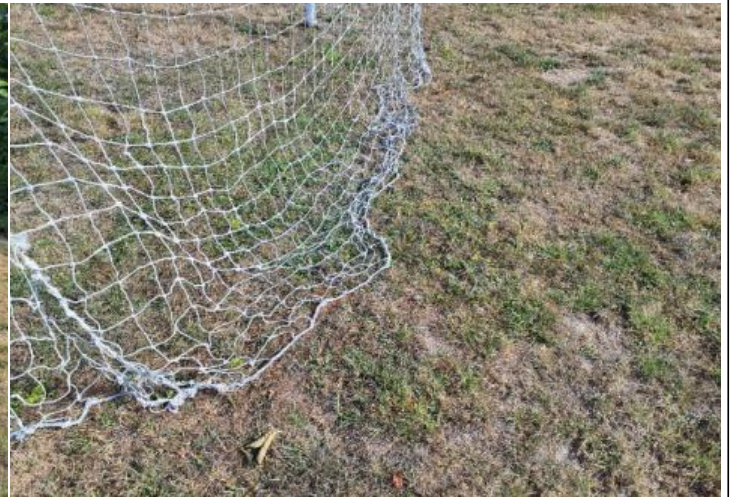
**Item:** Multi Use Games Area - Football Goal  
**Manufacturer:** Unknown  
**Risk Level:** L - Low Risk  
**Surface:** Grass

**Finding:** The net is not secured correctly  
**Action:** Refer to the manufacturers specification and rectify

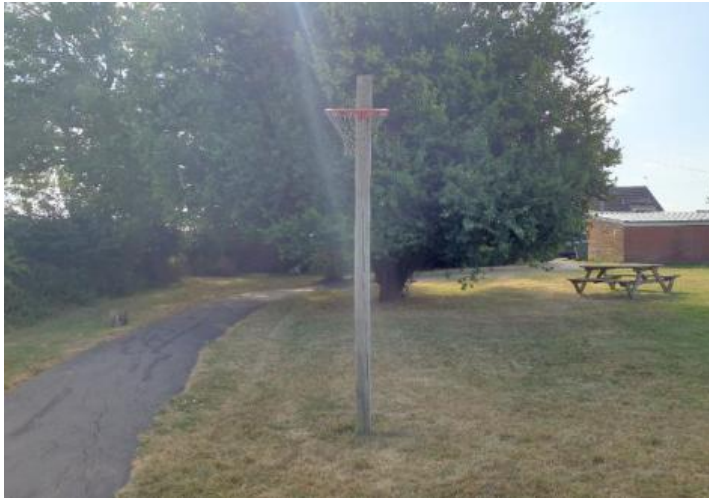
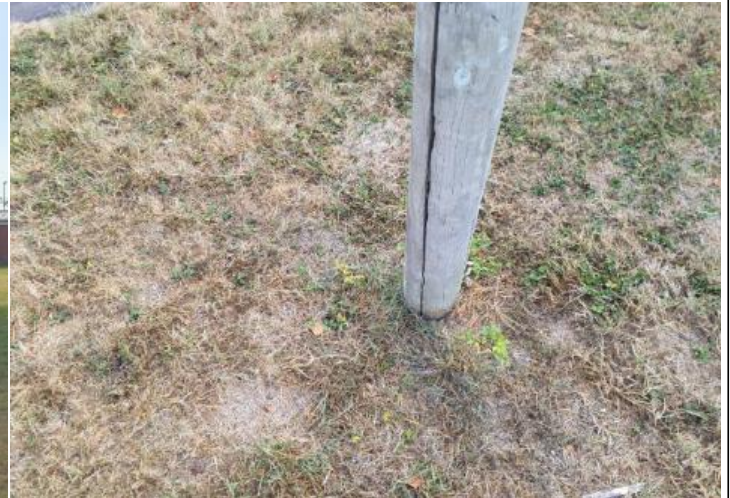
**Item:** Multi Use Games Area - Basketball Post      **Risk Level:** L - Low Risk  
**Manufacturer:** Owner/Operator      **Surface:** Grass

**Finding:** The timber has a number of splits/shakes or air cracks and this may affect the stability or allow water ingress which will accelerate the rotting process  
**Action:** Monitor to ensure the splits do not cross through fixing points of the structure and/or cause any instability

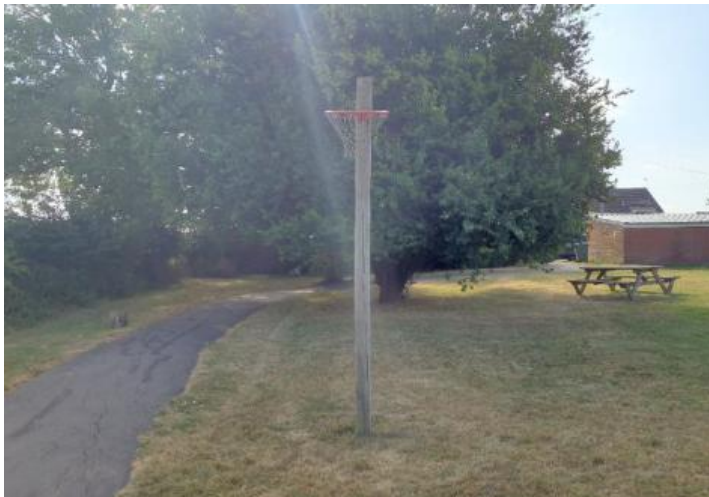
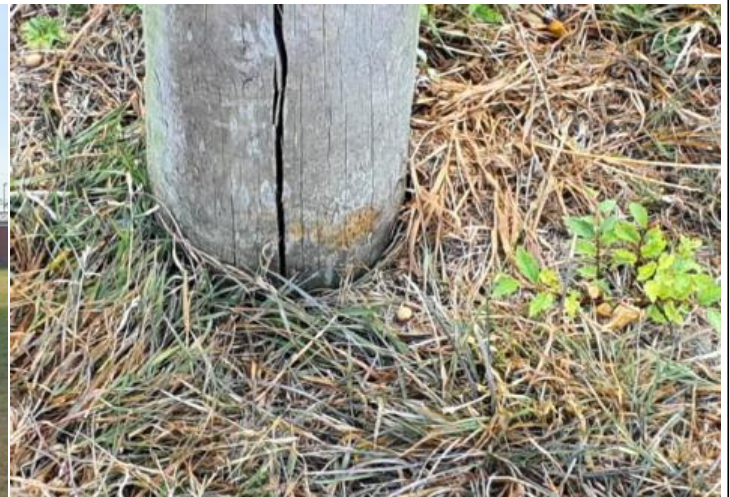
**Item:** Multi Use Games Area - Basketball Post      **Risk Level:** L - Low Risk  
**Manufacturer:** Owner/Operator      **Surface:** Grass

**Finding:** There is some strimmer / machinery damage apparent on the posts, this can penetrate the preservative applied to the timber and accelerate the rotting process  
**Action:** Monitor for any deterioration (rot) and replace as required

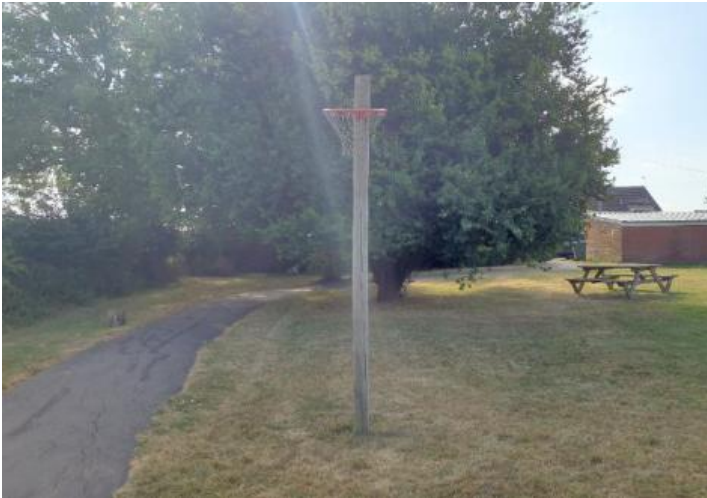
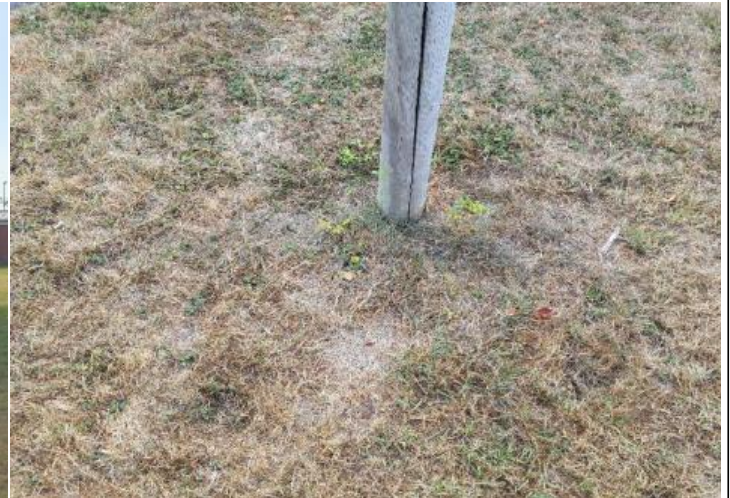
**Item:** Multi Use Games Area - Basketball Post  
**Manufacturer:** Owner/Operator

**Finding:** The item is slightly loose in its foundations

**Action:** Monitor for any further deterioration and repair as required

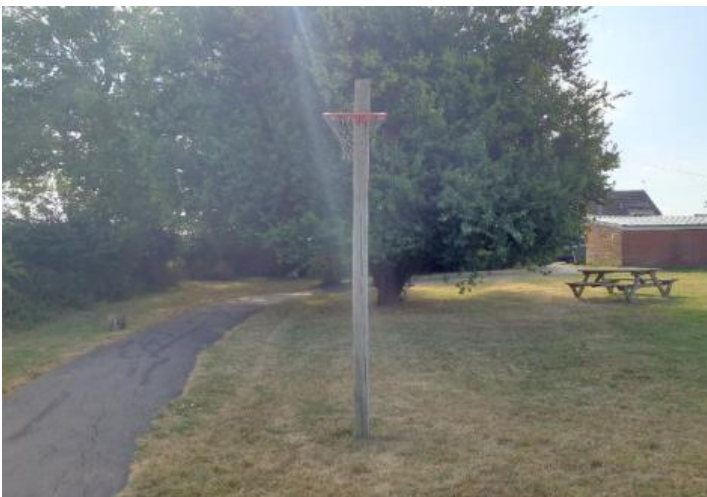
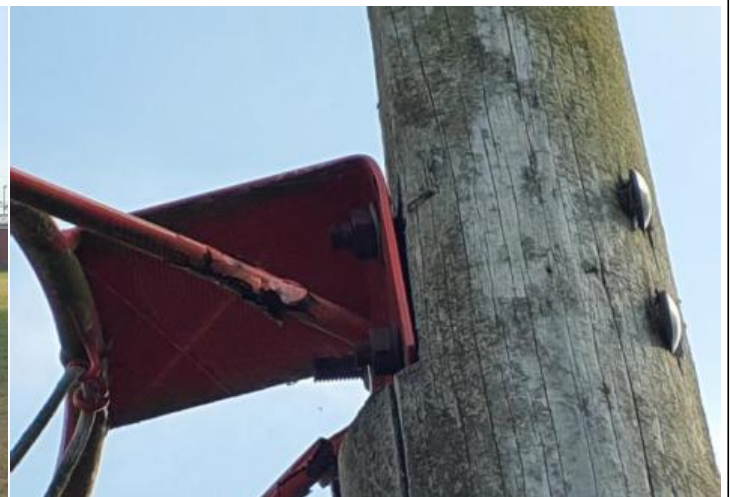
**Item:** Multi Use Games Area - Basketball Post  
**Manufacturer:** Owner/Operator

**Finding:** A number of fixing(s) have worked loose

**Action:** Secure all loose fixings

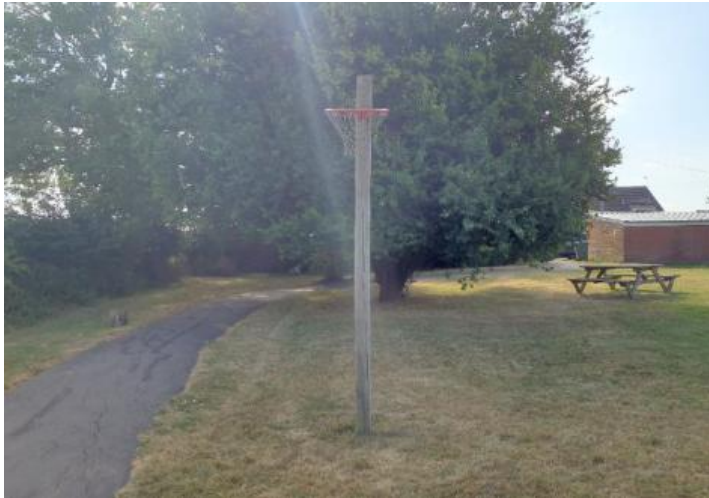
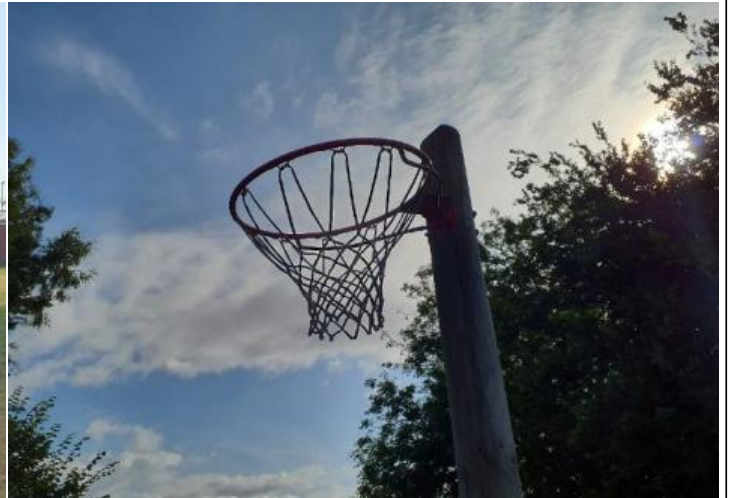
**Item:** Multi Use Games Area - Basketball Post  
**Manufacturer:** Owner/Operator

**Finding:** No backboard has been fitted

**Action:** Monitor and provide a backboard if required

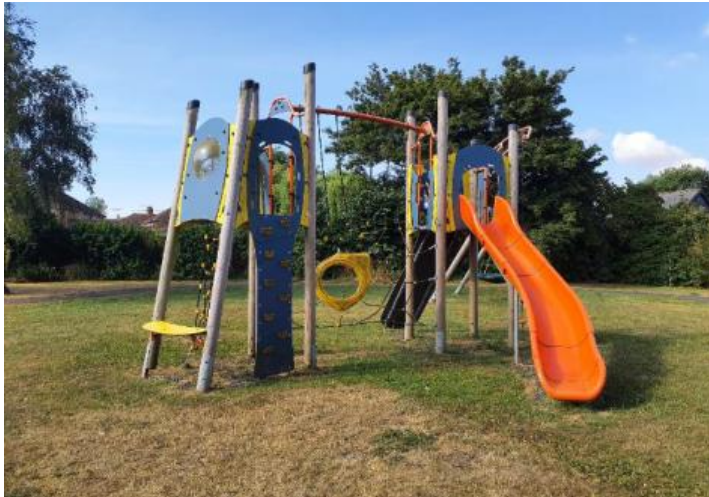
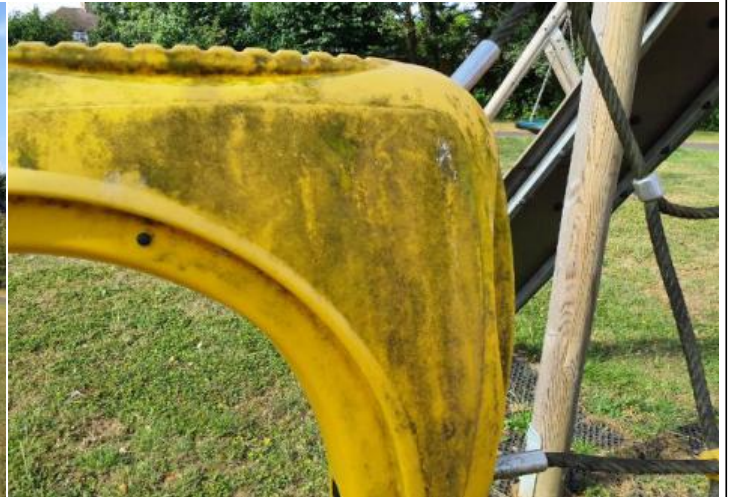
**Item:** Activity Equipment - Multi Play (Senior)  
**Manufacturer:** Playdale Playgrounds Ltd

**Finding:** There is algae or moss on the surface of the equipment

**Action:** Clean and treat appropriately

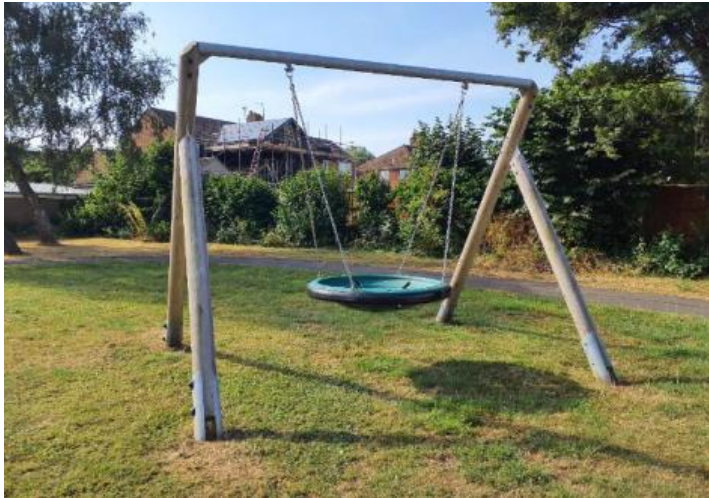
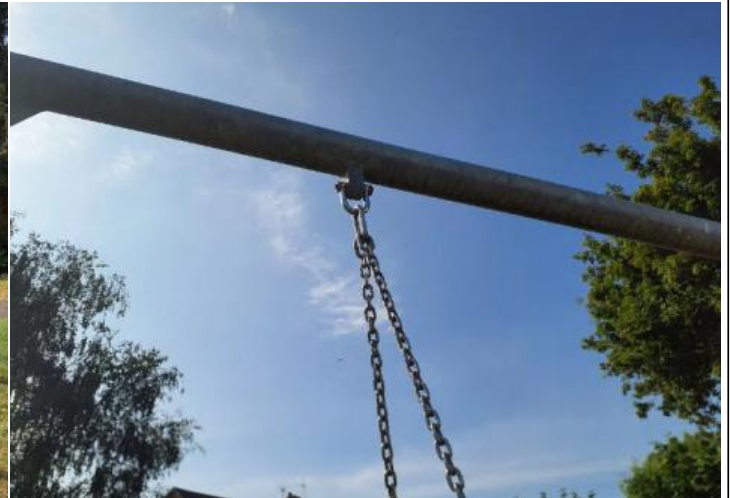
**Item:** Swings - Basket Swing - Type 1  
**Manufacturer:** Playdale Playgrounds Ltd

**Finding:** Swings of this design should have a secondary safety mechanism fitted to prevent collapse of the seat in the regular event of a joint failure to comply with BS EN 1176 Part 2, however this swing was installed prior to the standards being updated in 2018 and the manufacturer has confirmed that the joint was independently cycle tested by BSi

**Action:** Monitor use and check the joint and fixing security

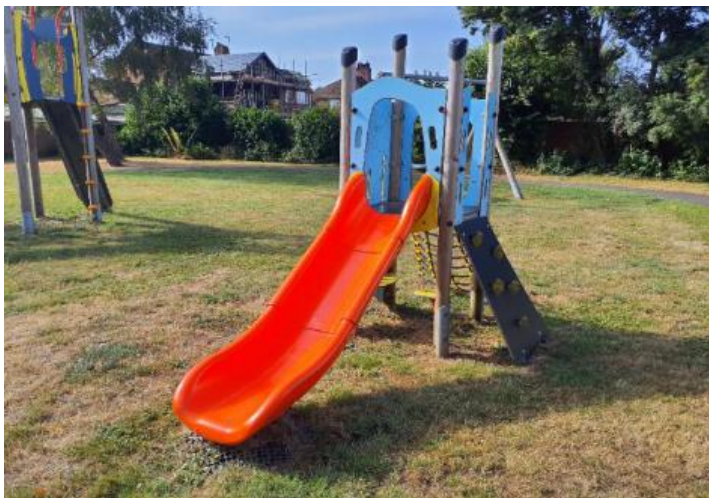
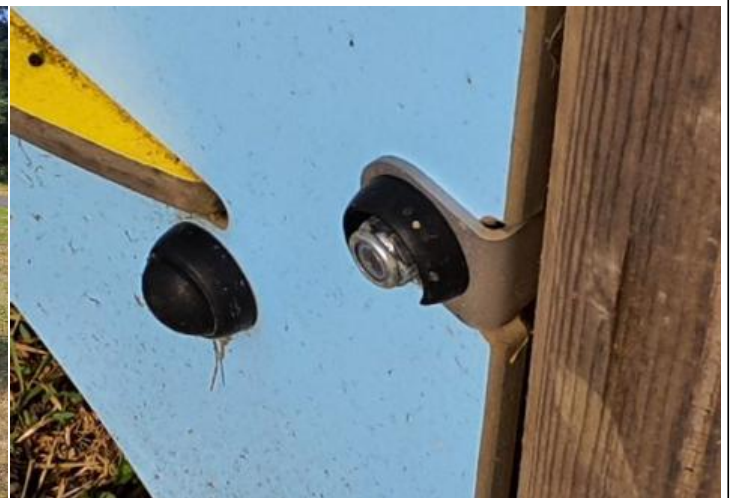
**Item:** Activity Equipment - Multi Play (Junior)  
**Manufacturer:** Playdale Playgrounds Ltd

**Finding:** There is/are bolt cap covers missing or damaged on the item

**Action:** Replace missing or damaged bolt cap covers
