## Annual Inspection

West Suffolk Parks

Hargrave

Playing Field, School Cottages, off Bury Road,  
Hargrave, IP29 5HR

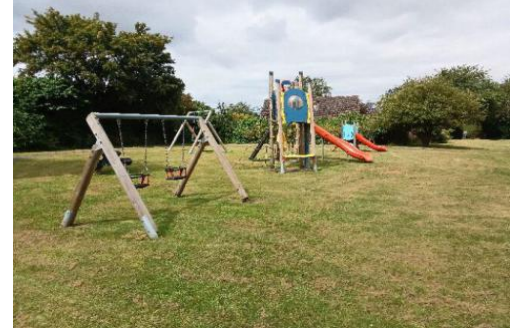
**Item:** Site General  
**Manufacturer:** Owner/Operator  
**Surface Type:** N/A  
**Item Part Number:**  
**Item Quantity:** 1  
**Equipment Compliance:** N/A  
**Surface Area Compliance:** N/A  
**Total Findings:** 2

It is recommended that signage, with information including the site address, contact information for maintenance issues and emergency contact details are provided for the facility - Provide in accordance with the recommendations

There are trip hazards at the edges of the drain cover - Reinstate surrounding surface levels to remove the trip points

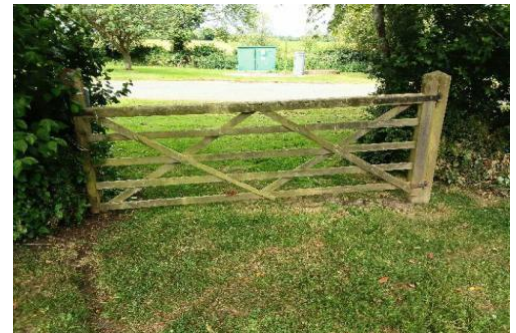
**Item:** Gate - Maintenance  
**Manufacturer:** Not Identified  
**Surface Type:** Grass  
**Item Quantity:** 1  
**Equipment Compliance:** N/A  
**Surface Area Compliance:** N/A  
**Total Findings:** 4

The area under the gate has eroded leaving uneven areas, or the concrete foundations exposed, resulting in trip hazards at the entrance/exit to the playground - Reinstate to level with surrounding surfaces

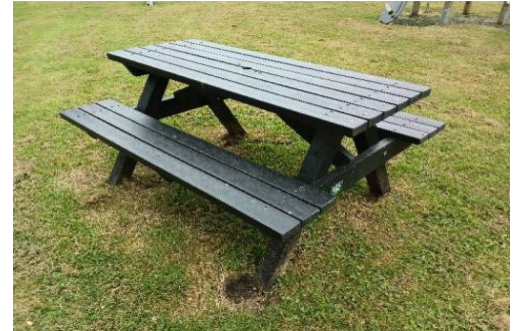
**Item:** Picnic Table  
**Manufacturer:** Not Identified  
**Surface Type:** Grass  
**Item Quantity:** 1  
**Equipment Compliance:** N/A  
**Surface Area Compliance:** N/A

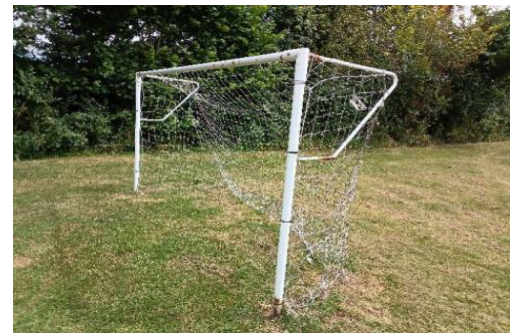
**Item:** Football Goal  
**Manufacturer:** Not Identified  
**Surface Type:** Grass  
**Item Quantity:** 1  
**Equipment Compliance:** N/A  
**Surface Area Compliance:** N/A

The item is slightly loose in its foundations - Monitor for any further deterioration and repair as required

The paintwork on this item has been damaged or worn exposing the metal underneath which is rusting / corroding - Treat affected areas and repaint

Cable ties have been used on the item and there are sharp projecting ends - Remove if not required or replace with a more appropriate alternative fixing method if used as a fixing

The net is damaged - Repair or replace the item / affected part

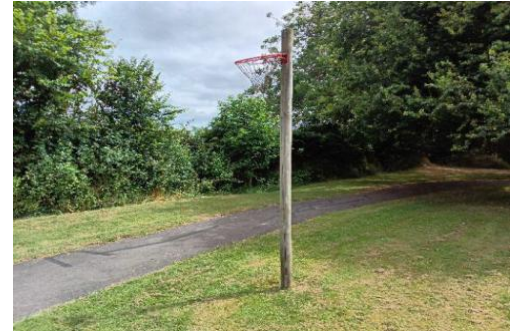
**Item:** Basketball Post  
**Manufacturer:** Not Identified  
**Surface Type:** Grass  
**Item Quantity:** 1  
**Equipment Compliance:** Yes  
**Surface Area Compliance:** N/A

The item is slightly loose in its foundations - Monitor for any further deterioration and repair as required

There is some strimmer / machinery damage apparent on the posts, this can penetrate the preservative applied to the timber and accelerate the rotting process - Monitor for any deterioration (rot) and replace as required

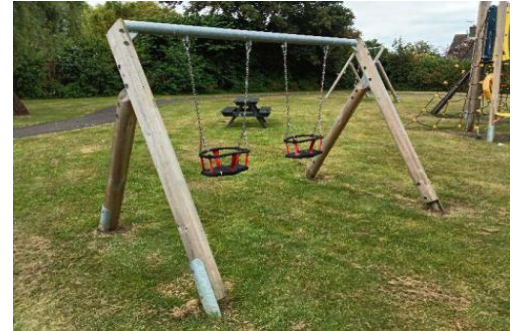
**Item:** 1 Bay 2 Seat (Cradle)  
**Manufacturer:** Playdale Playgrounds Ltd  
**Surface Type:** Grass Matrix Tiles  
**Item Quantity:** 1  
**Equipment Compliance:** Yes  
**Surface Area Compliance:** Yes

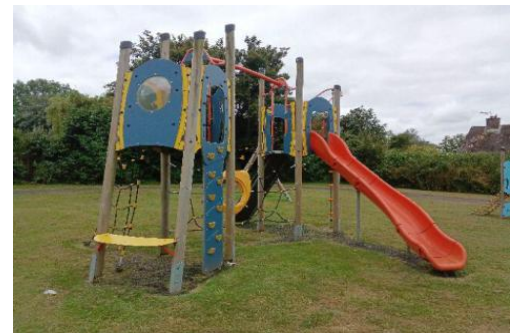
**Item:** Multi Play (Senior)  
**Manufacturer:** Playdale Playgrounds Ltd  
**Surface Type:** Grass Matrix Tiles  
**Item Quantity:** 1  
**Equipment Compliance:** Yes  
**Surface Area Compliance:** Yes

A number of fixing(s) have worked loose - Secure all loose fixings

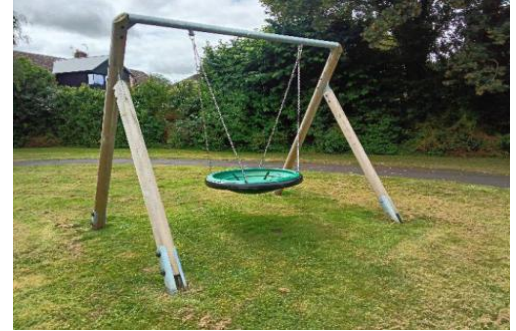
**Item:** Basket Swing - Type 1  
**Manufacturer:** Playdale Playgrounds Ltd  
**Surface Type:** Grass Matrix Tiles  
**Item Quantity:** 1  
**Equipment Compliance:** No  
**Surface Area Compliance:** Yes

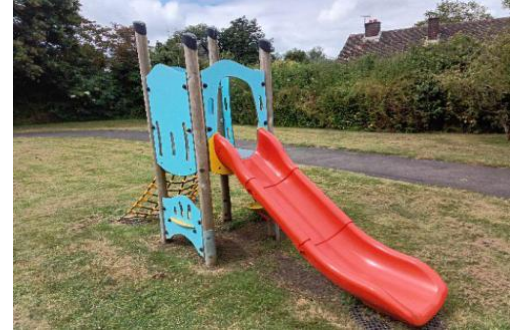
**Item:** Multi Play (Junior)  
**Manufacturer:** Playdale Playgrounds Ltd  
**Surface Type:** Grass Matrix Tiles  
**Item Quantity:** 1  
**Equipment Compliance:** Yes  
**Surface Area Compliance:** Yes
